# **Bicyclist Safety Action Plan**

## **Osceola, Orange, and Seminole Counties, Florida**

Prepared for MetroPlan Orlando

Prepared by Kittelson & Associates, Inc.

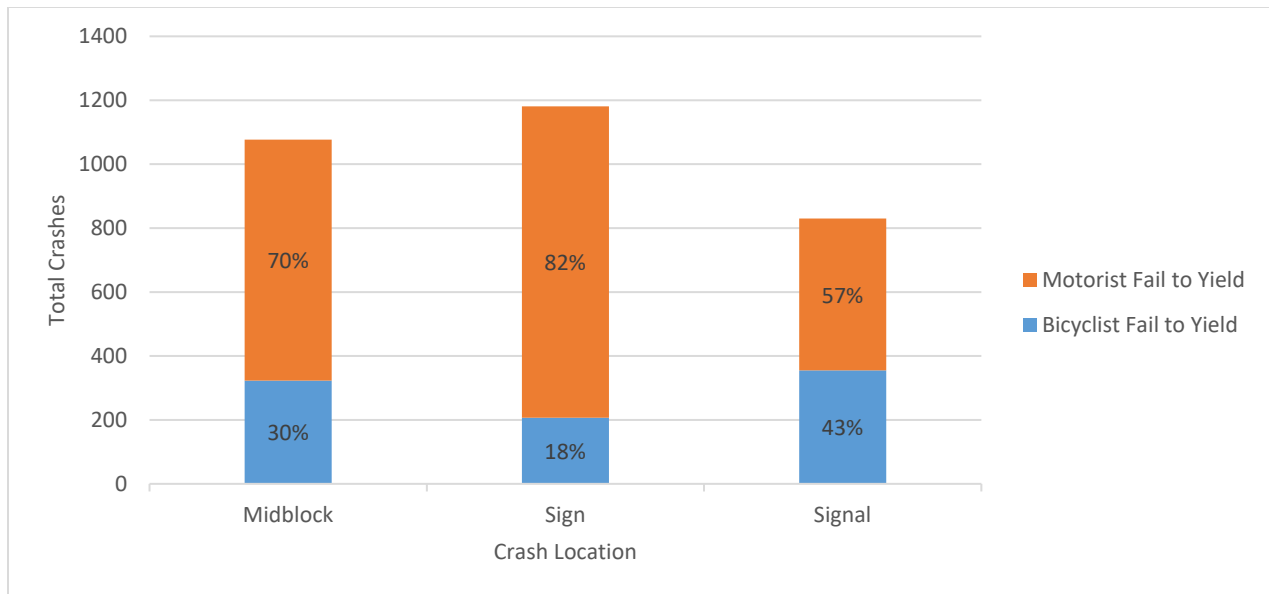
*Figure 16. Bicyclist Crashes by Location and Fault*

The recorded bicyclist crash types and crash groups can be aggregated into one of two primary categories: Motorist Failure to Yield and Bicyclist Failure to Yield. Overall, among the 60 percent of crashes that fall into one of these two categories, Motorist Failure to Yield is the primary fault in 71 percent of crashes. The majority of bicyclist crashes can be described as occurring at one of three location types: midblock, sign-controlled intersections, or signalized intersections. Motorist vs Bicyclist Failure to Yield at each of these three locations is depicted in **Figure 16**. While Motorist Failure to Yield crashes constitute the majority of crashes at each of the three locations, the split is closer to 50/50 at signalized intersections, where bicyclists often do not have dedicated signals capable of detecting their presence.

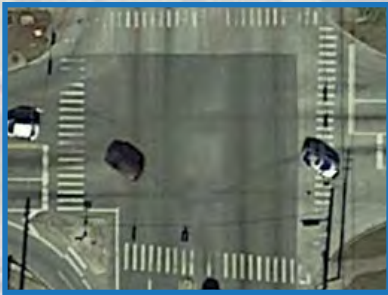
**Issue #18:**  
Crosswalk markings should be upgraded to special emphasis markings.

**Recommendation #18:**  
Restripe with special emphasis markings for all crosswalks.

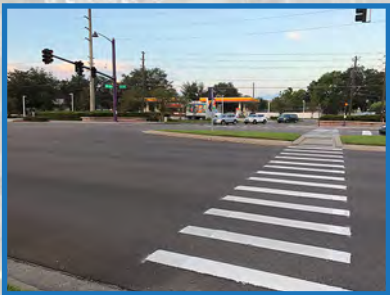
**Siesta Lago Drive Issue #2:**  
There is no pedestrian push button at the mid-block island on the north leg of the intersection.

**Siesta Lago Drive Issue #1:**  
Pedestrians/bicyclists conflict with vehicles in north leg marked crosswalk.

**Siesta Lago Drive Recommendation #2:**  
Install a pedestrian push button at the mid-block island on the north leg of the intersection.

**Siesta Lago Drive Recommendation #1:**  
Implement leading pedestrian interval for the north leg crosswalk.

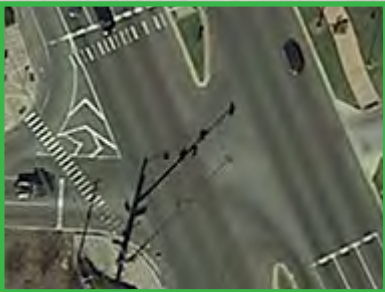
**Siesta Lago Drive Issue #3:**  
No marked crosswalk on the south leg of the intersection.

**Siesta Lago Drive Recommendation #3:**  
Add special emphasis crosswalk with curb ramps and truncated domes on south leg.

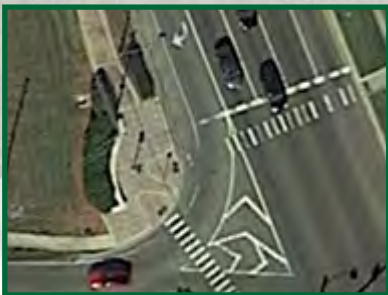
**Siesta Lago Drive Issue #4:**  
A wide southbound right turning radius encourages high turning speeds and the painted island does not discourage high speed turns..

**Siesta Lago Drive Recommendation #4:**  
Convert painted island to a raised island and consider a raised crosswalk within the channelized right turn lane.

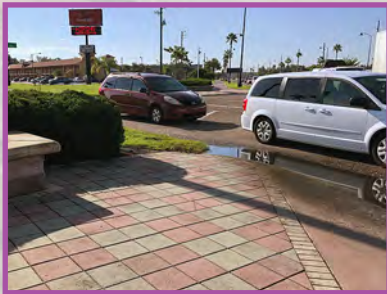
**Old Vineland Road Issue #7:**  
The hedges at the northeast corner of the intersection obstruct sight distance.

**Old Vineland Road Recommendation #7 :**  
Cut the hedges to improve sight distance.

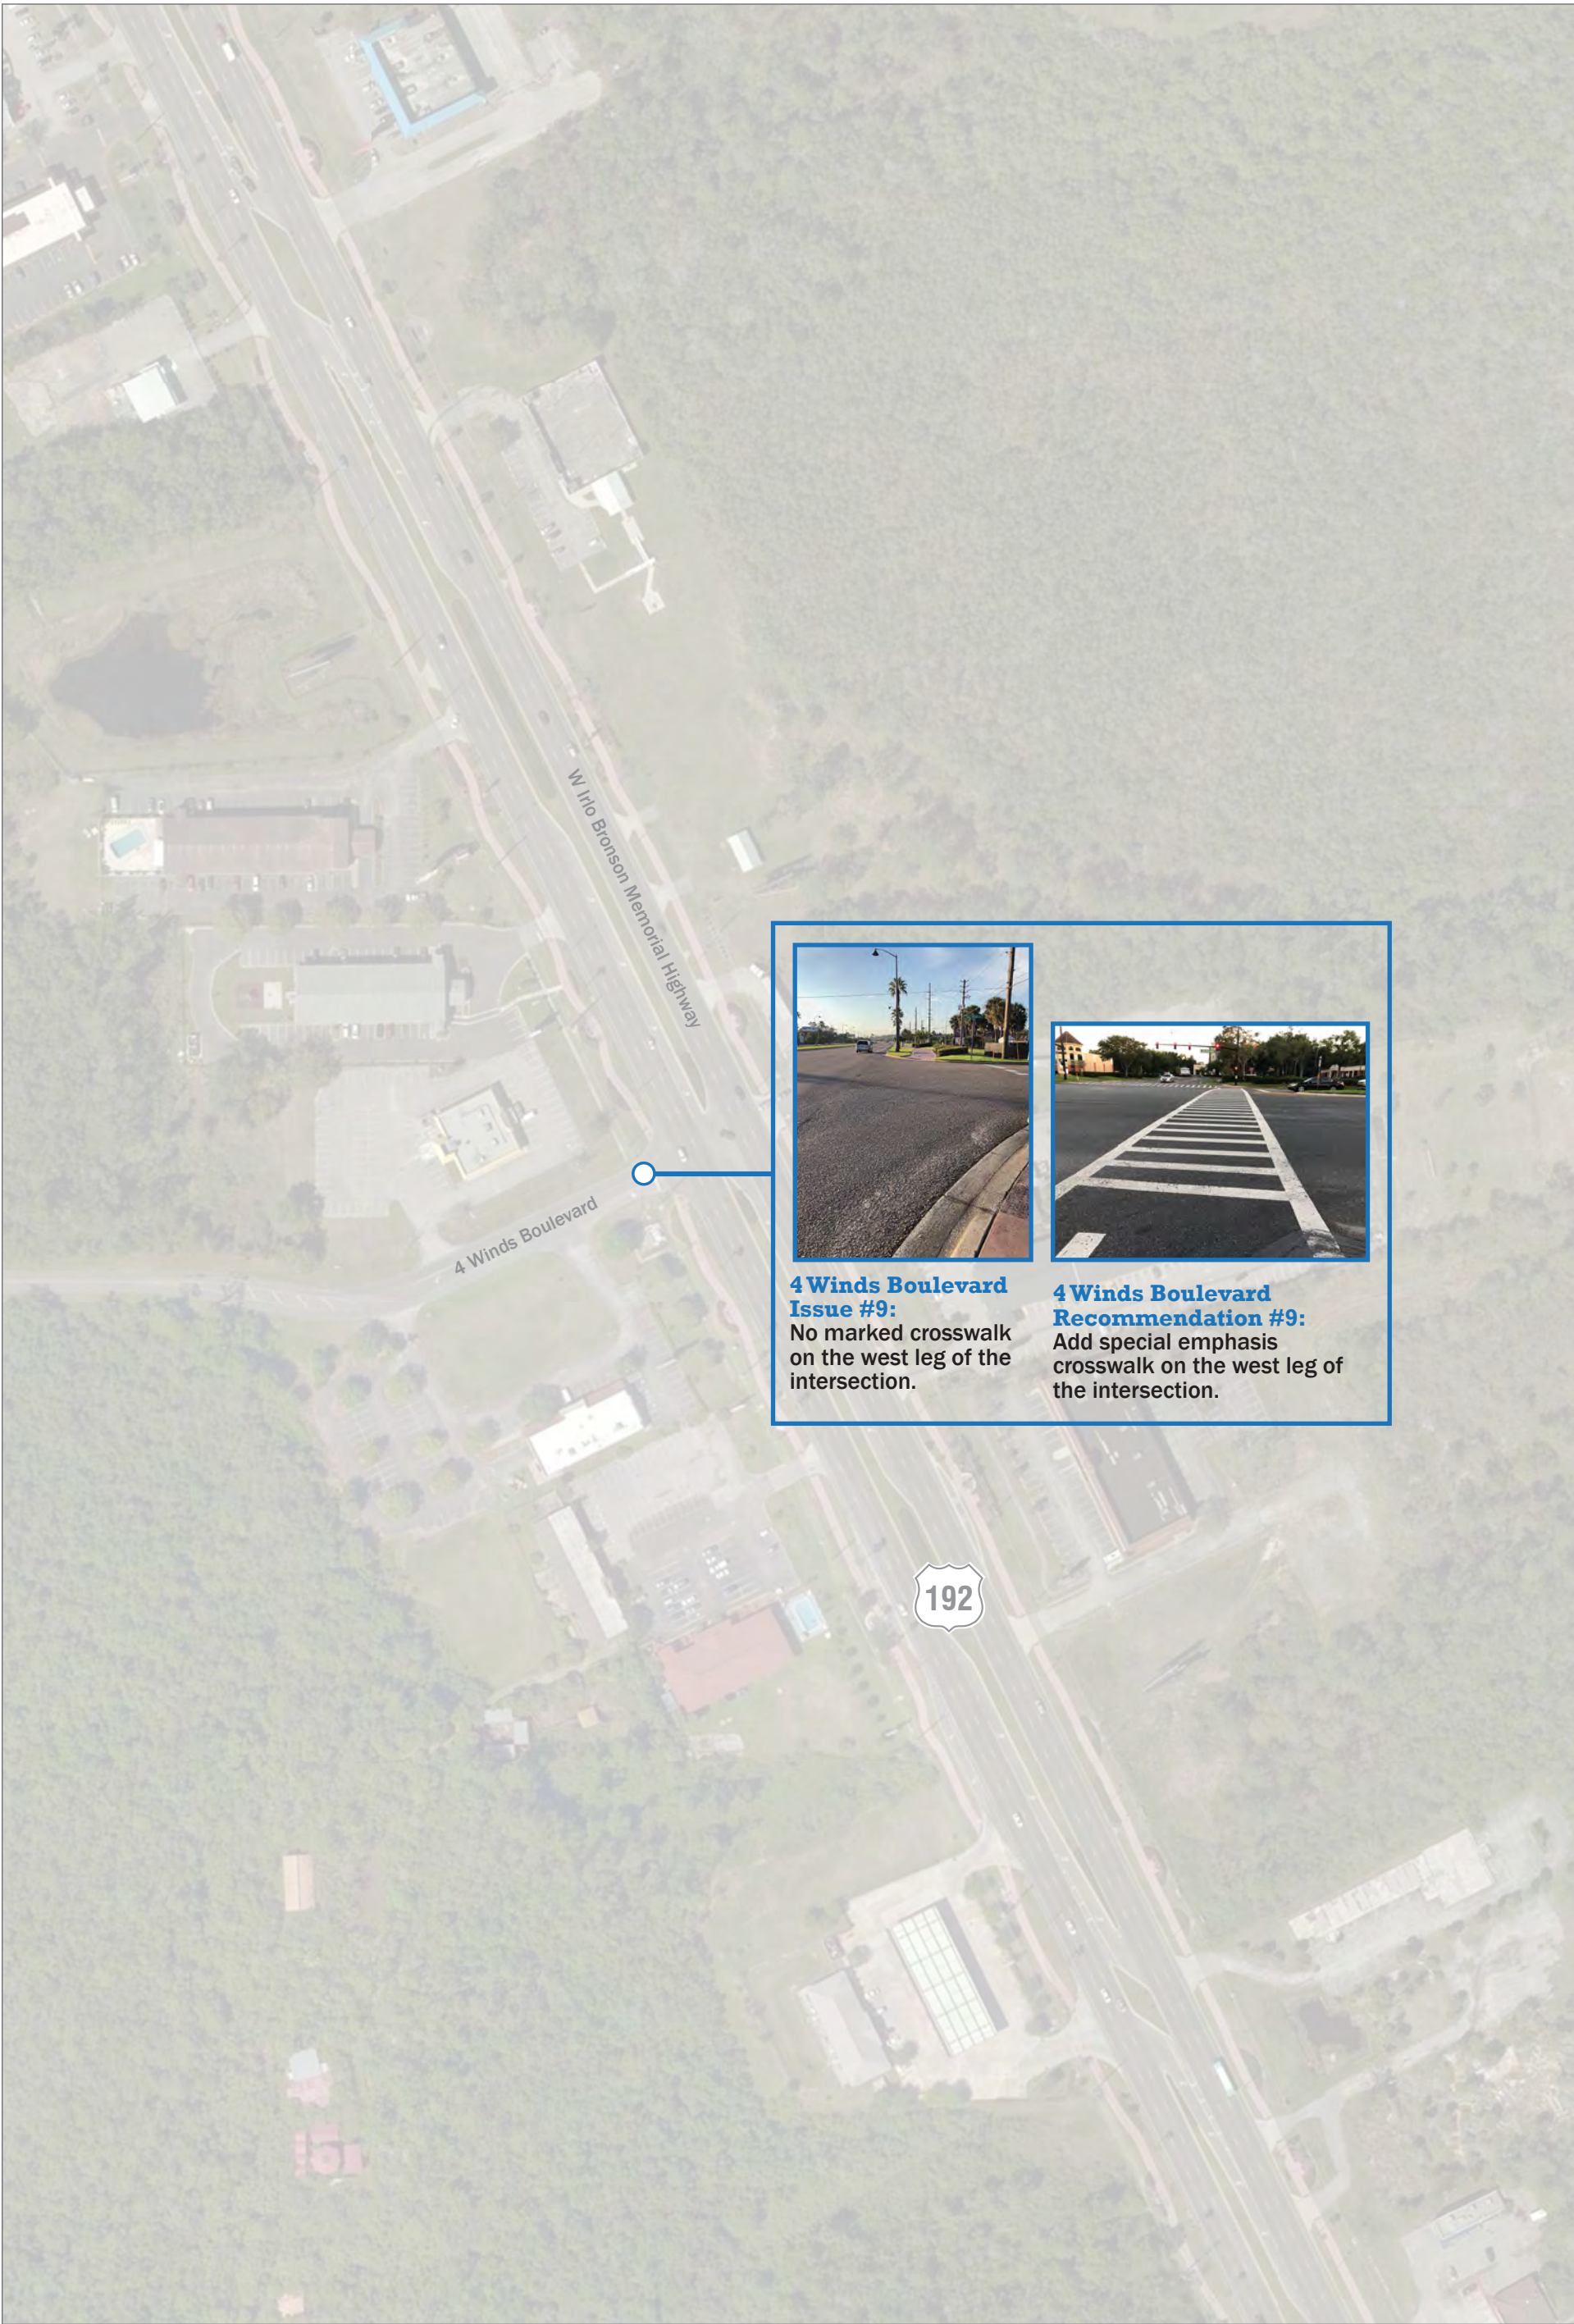
**4 Winds Boulevard  
Issue #9:**  
No marked crosswalk  
on the west leg of the  
intersection.

**4 Winds Boulevard  
Recommendation #9:**  
Add special emphasis  
crosswalk on the west leg of  
the intersection.

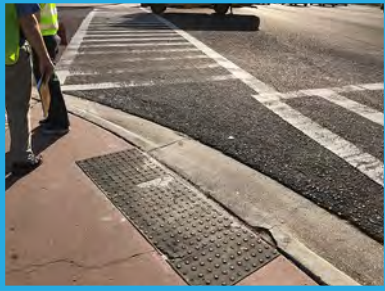
**Old Vineland Road (S)**  
**Issue #12:**  
Pedestrian crosswalk markings faded.

**Old Vineland Road (S)**  
**Recommendation #12:**  
Restripe the crosswalks on all legs of the intersection with special emphasis markings.

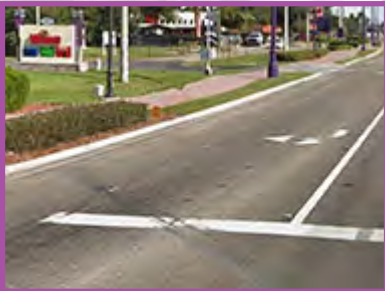
**Old Vineland Road (S)**  
**Issue #15:**  
The eastbound and westbound bike lane is faded and conflicts with right turn vehicle movements.

**Old Vineland Road (S)**  
**Recommendation #15:**  
Re-stripe the bike lanes in the eastbound and westbound direction so that a bike lane keyhole runs between the through lane and right turn lane.

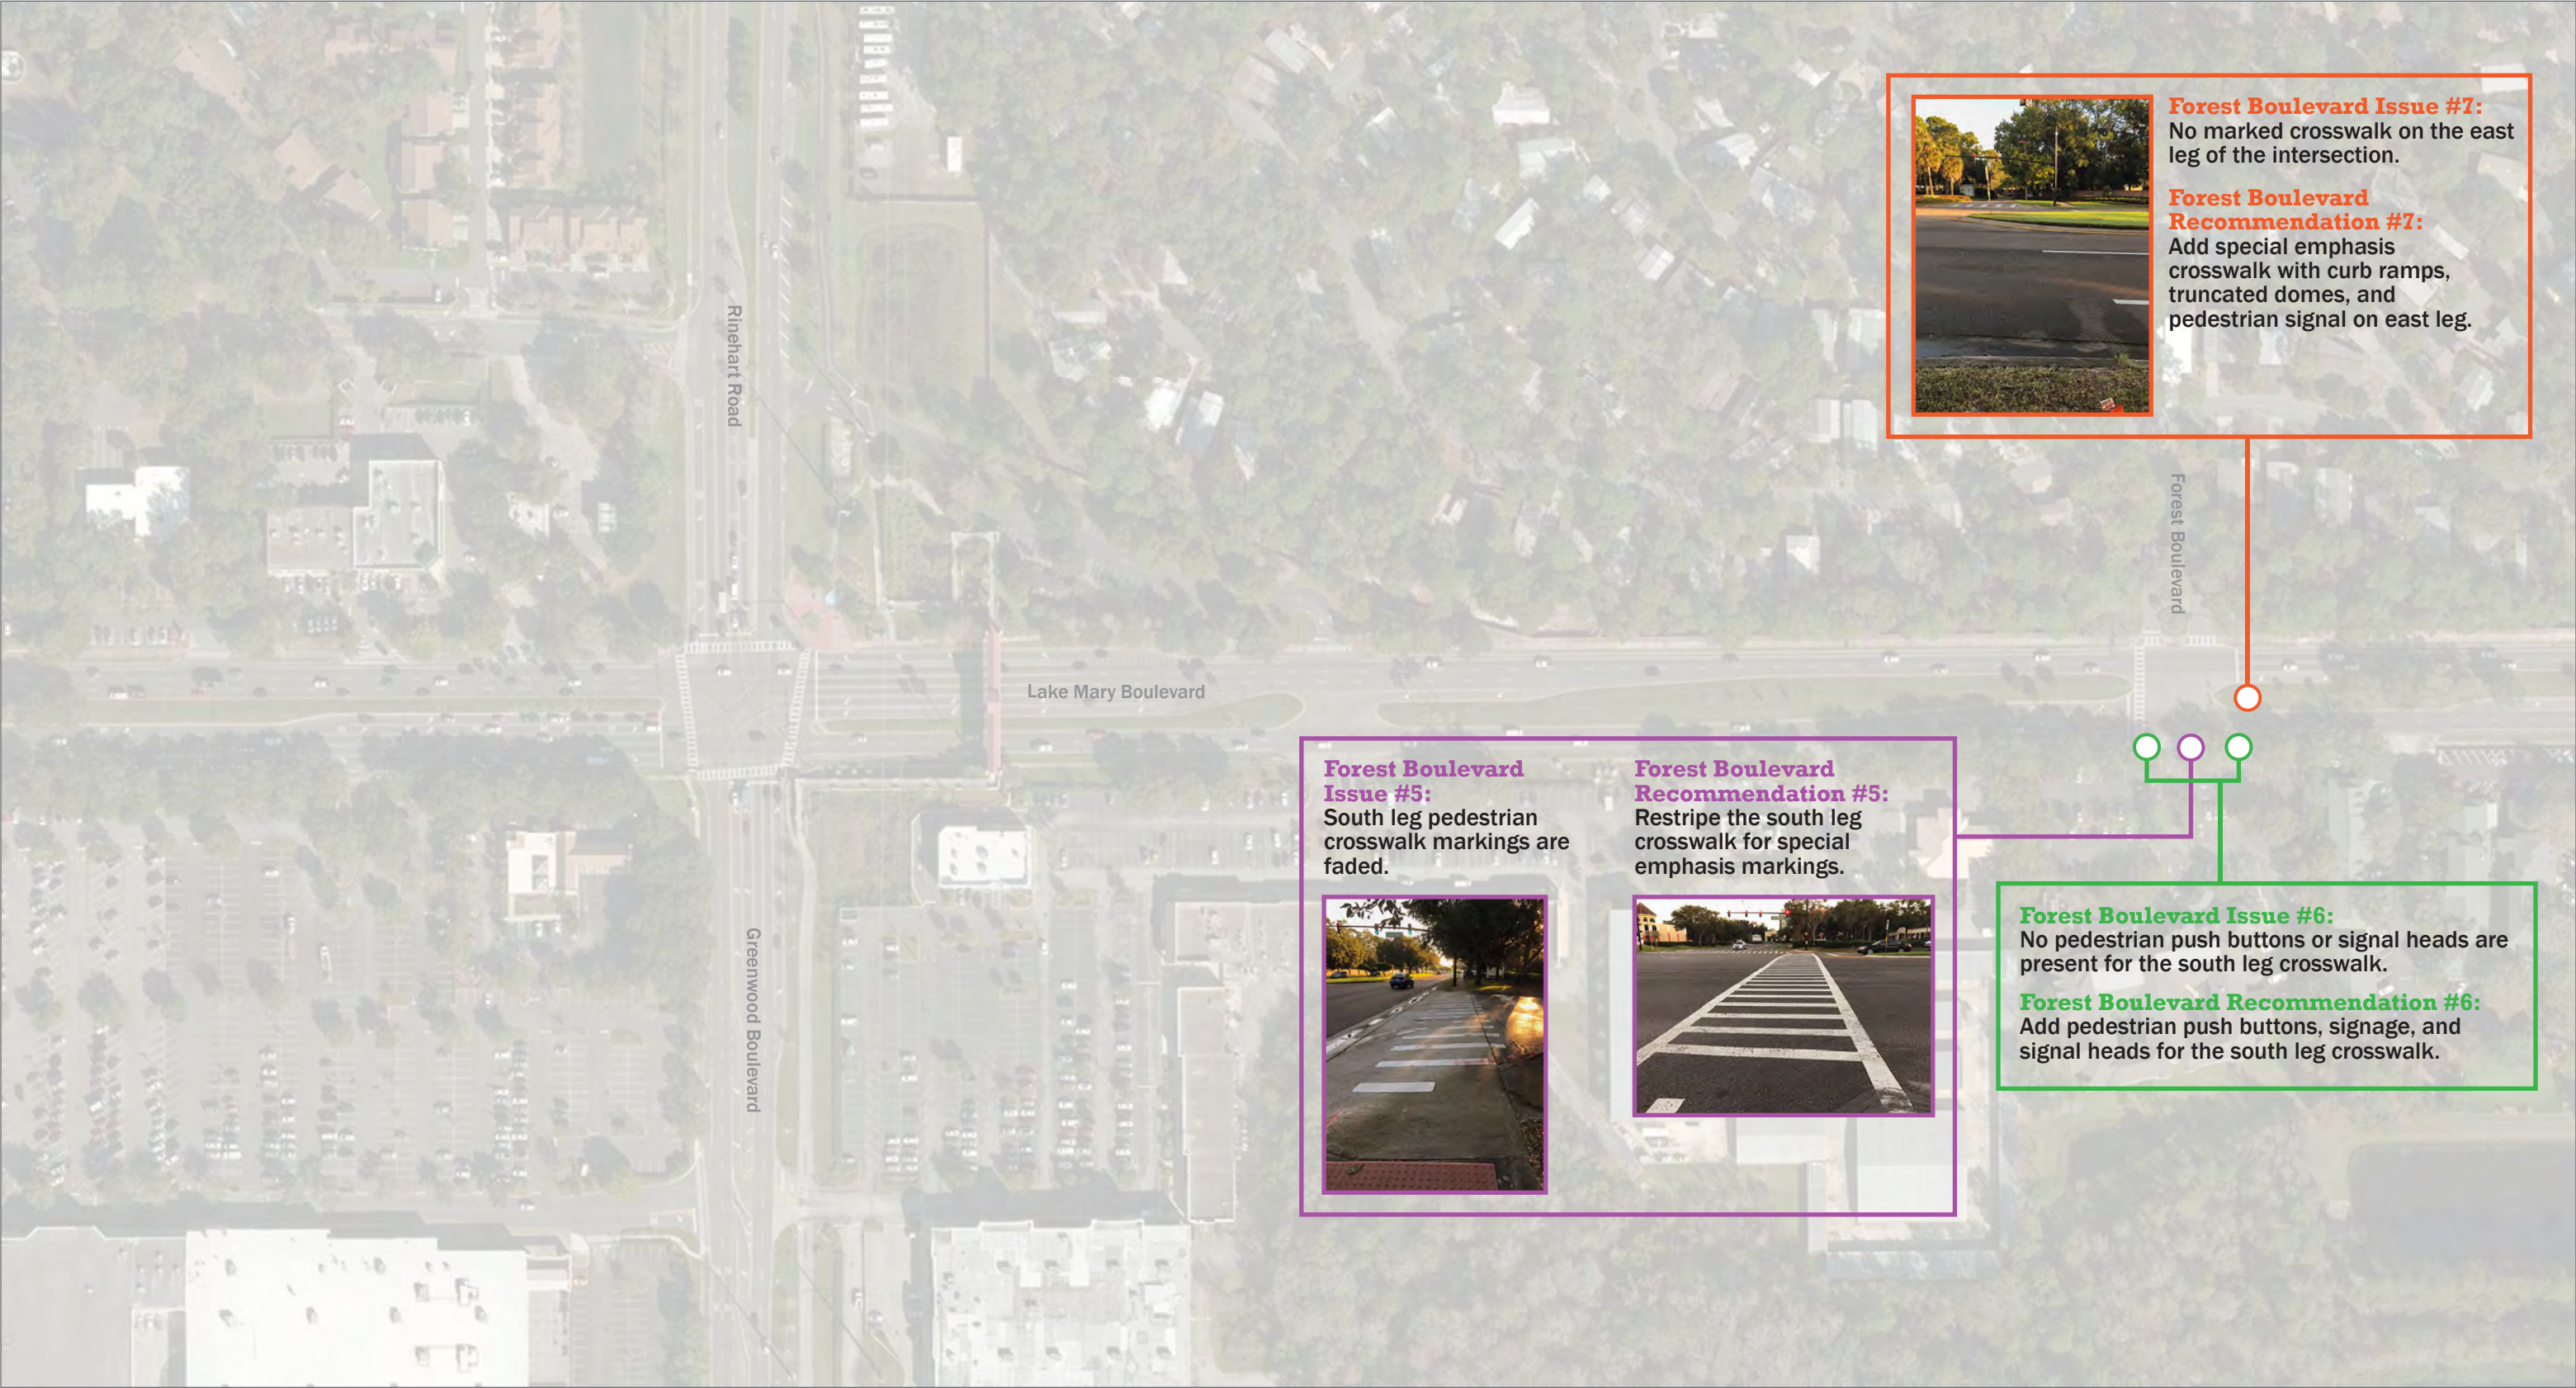
**Post Office Driveways Issue #9:**  
No marked crosswalks across the driveways. Truncated domes are damaged or are missing.

**Post Office Driveways Recommendation #9:**  
Add special emphasis crosswalks across the driveways and repair the broken truncated domes.

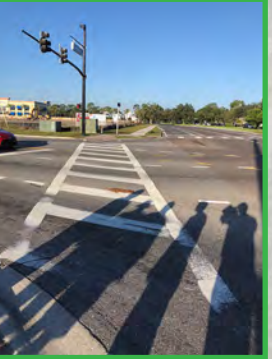
**Longwood/Lake Mary Road Issue #13:**  
The south leg crosswalk is skewed, and northbound vehicles were observed stopping in the crosswalk due to the skew.

**Longwood/Lake Mary Road Recommendation #13:**  
Make the crosswalk parallel to Lake Mary Boulevard by shifting the west side further to the north.

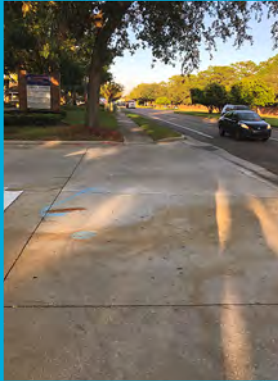
**Waymont Court Issue #8:**  
No marked crosswalk or truncated domes on the south leg of the intersection.

**Waymont Court Recommendation #8:**  
Add special emphasis crosswalk with truncated domes on south leg.

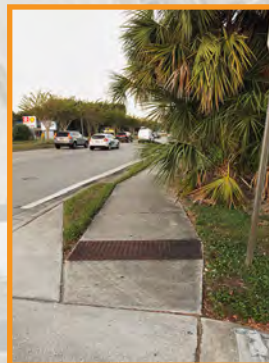
**Wells Fargo Entrance Issue #9:**  
The bushes on the northwest corner of the intersection obstruct sight distance.

**Wells Fargo Entrance Recommendation #9:**  
Cut the bushes to improve sight distance.

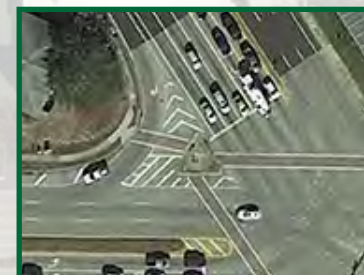
**Tuskawilla Road Issue #12:**  
The raised pedestrian refuge on the northwest corner of the intersection is small and the southbound right turn lane is wide, which encourages high turning speeds.

**Tuskawilla Road Recommendation #12:**  
Increase the size of the raised pedestrian refuge to increase pedestrian and bicyclist comfort and reduce driver turning speeds. Also consider a raised crosswalk within the channelized right turn lane.

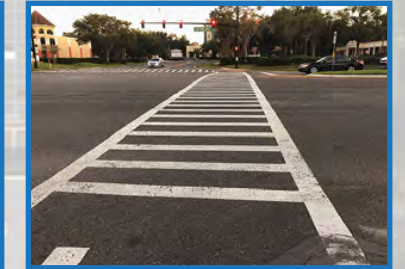
Pedestrian crosswalk markings and stop bar faded on the east leg of the intersection.

Restripe the crosswalk and stop bar on the east leg of the intersection with special emphasis markings.

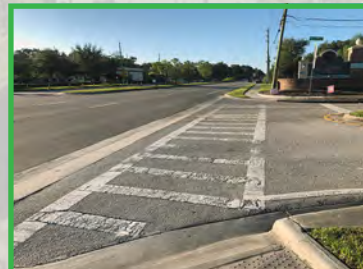
Pedestrian crosswalk markings faded on the west leg of the intersection.

Restripe and resurface the crosswalk on the west leg of the intersection with special emphasis markings.

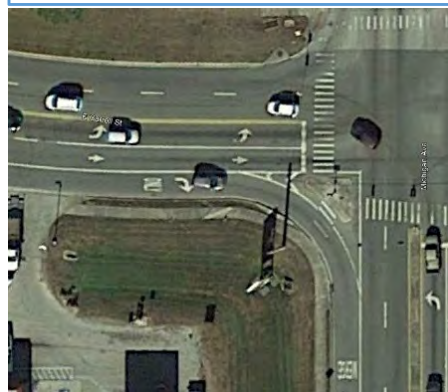
Free-flow eastbound right turn lane at Carroll Street (Issue #17)

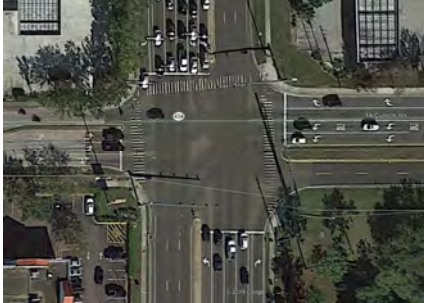
No marked crosswalk on the south leg of McCulloch Road (Issue #1)

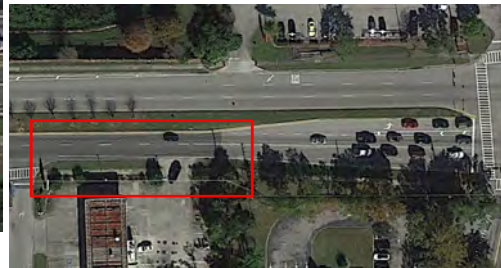
EB bike lane ends near Shell gas station driveway before reaching Plaza Entrance signal (Issue 10)

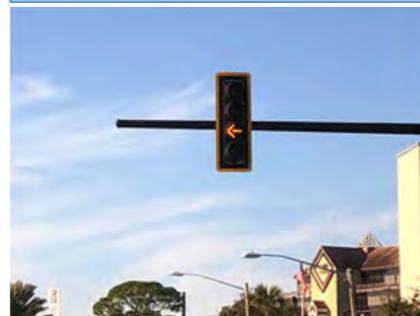
Permissive EB/WB left turn vehicles conflict with school children at Mills Avenue (Issue #22)

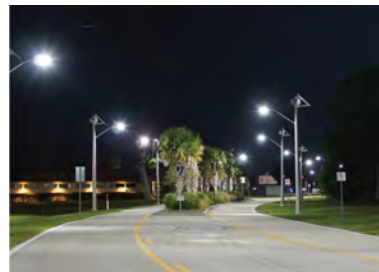
Very few corridors with street lighting;  
nighttime ped/bike crashes between 25 and 45  
percent

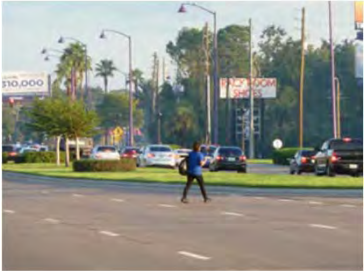
Multiple fatal crashes occurred with peds/bikes crossing mid-block

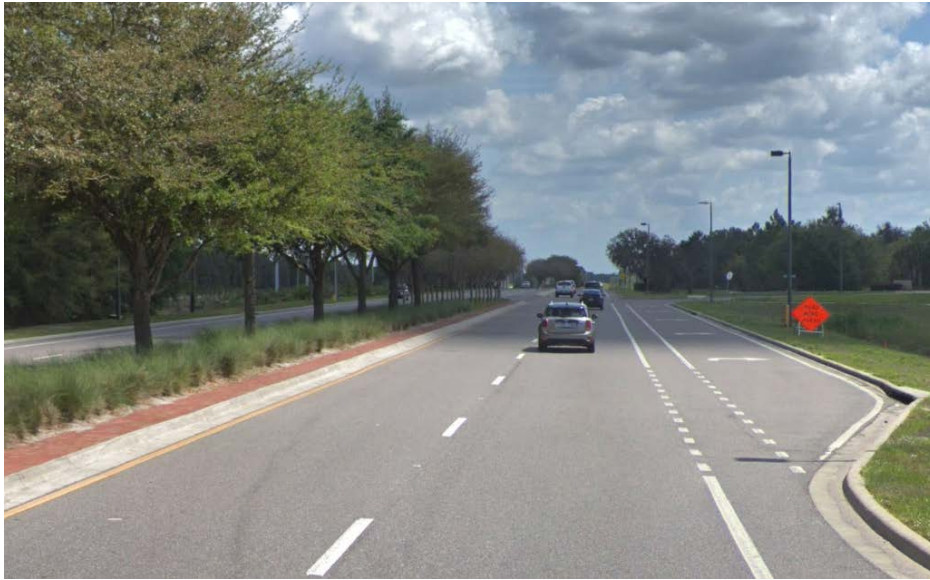
### *Keyhole Lane Markings*

Keyhole Through a Right-Turn Lane

Issue: Bicyclists traveling on the edge of the roadway or in a bicycle lane approaching an intersection with a right-turn lane should not continue to the outside of the turn lane if they are not making a right-turn at the intersection.

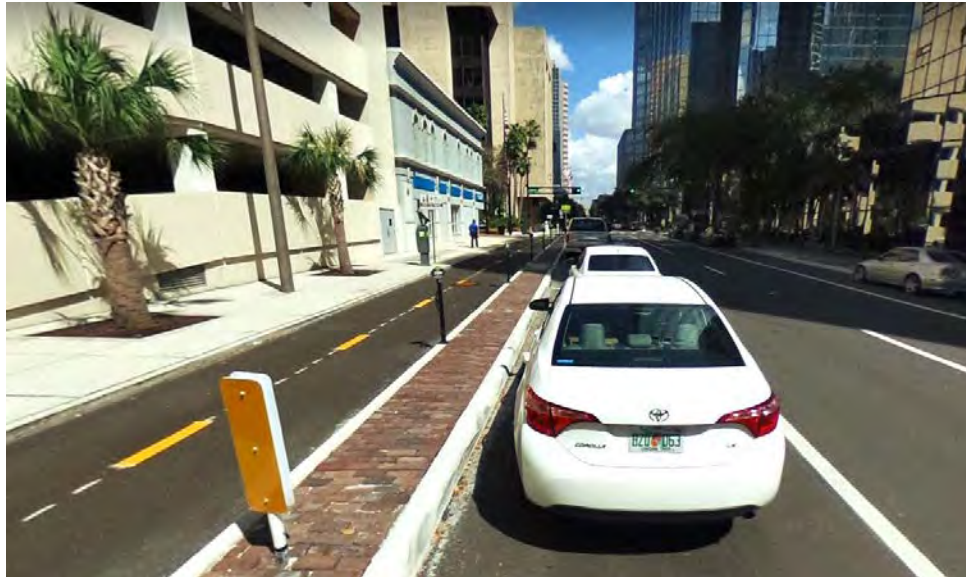
*Shared Use Path or Bi-Directional Cycle Track (One Side)*

Bi-Directional Cycle Track Along a One-Way Roadway

Issue: Bicyclists traveling on the sidewalk or on the edge of the roadway without sufficient space/buffer from vehicles. Limited available right-of-way, high speeds, high traffic volumes, or one-way roadways may lead to potential issues that cannot be addressed through implementation of bike lanes on both sides of the roadway.

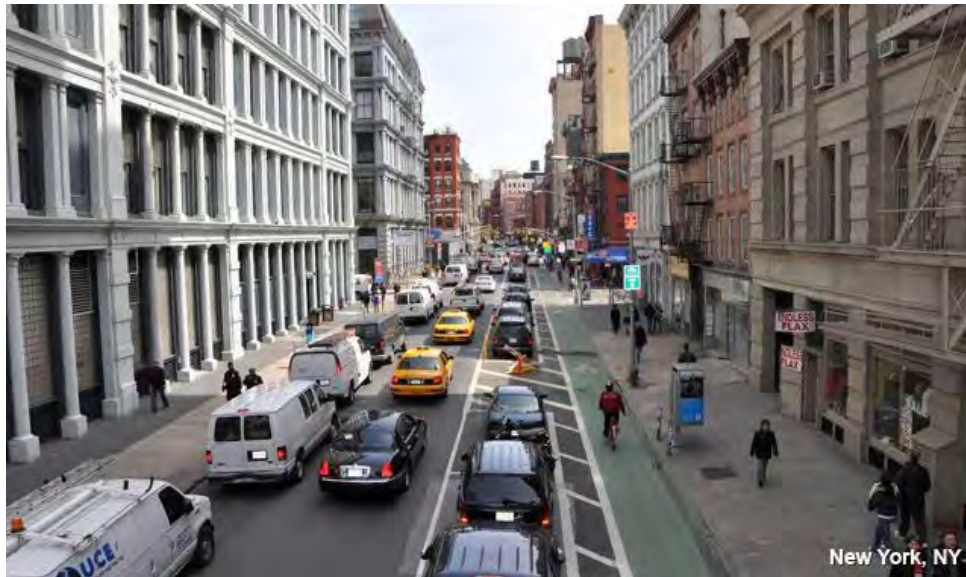
### *Unidirectional Cycle Track*

Unidirectional Cycle Track along a One-Way Roadway

Issue: Bicyclists traveling on the sidewalk or on the edge of the roadway without sufficient space/buffer from vehicles. Bicyclists traveling against the flow of traffic on one-way roadways. Limited available right-of-way, high speeds, high traffic volumes, or one-way roadways may lead to potential issues that cannot be addressed through implementation of bike lanes on both sides of the roadway.

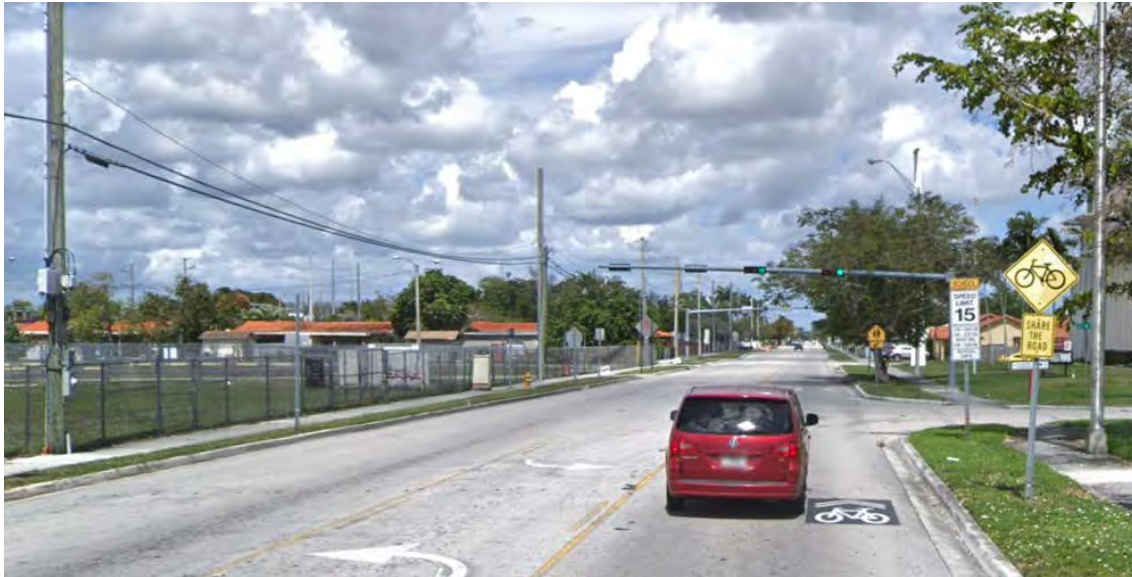
## *Sharrows*

Sharrow with Signage

Issue: Lack of right-of-way or cost concerns with providing dedicated bicycle facilities.

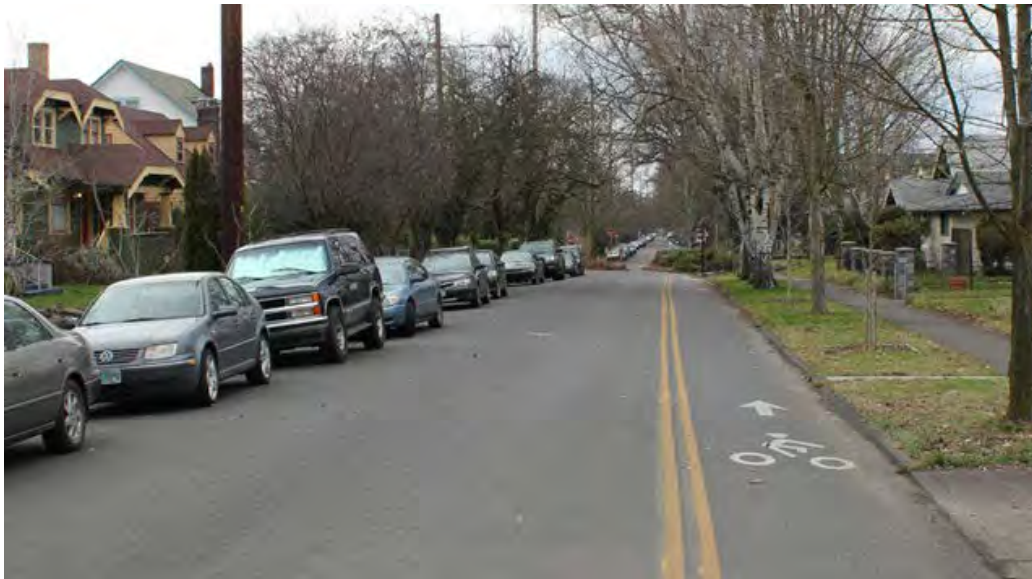
### *Contraflow Bicycle Lane*

Contraflow Bicycle Lane

Issue: Poor bicycle network connectivity and/or bicyclists riding on the sidewalk, against traffic, or on high volume/speed roadways in order to complete their route via the shortest possible distance.
