Pedestrian Safety Action Plan

Osceola, Orange, and Seminole Counties, Florida

Prepared for MetroPlan Orlando

Prepared by Kittelson & Associates, Inc.

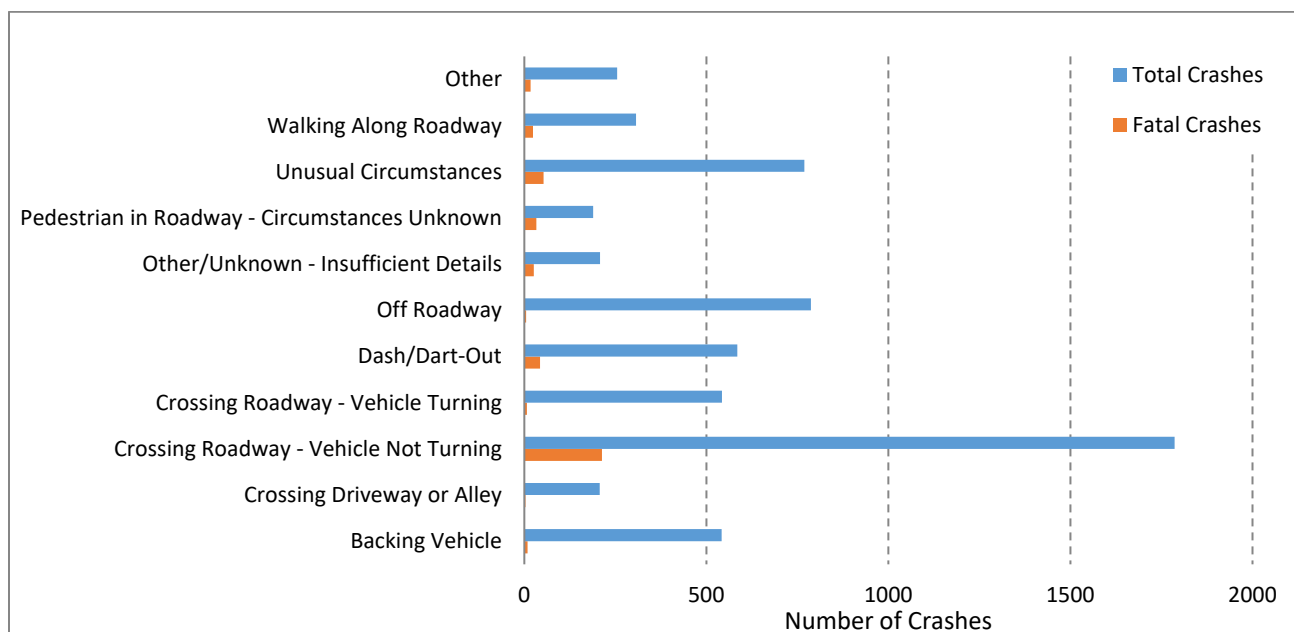
Figure 12. Prevalent Pedestrian Crash Types

The most prevalent pedestrian crash type involved a pedestrian crossing a roadway with a non-turning vehicle, accounting for 29 percent of all pedestrian crashes and 49 percent of all fatal pedestrian crashes. This crash type is typically associated with higher speed crashes, resulting in higher proportion of fatal crashes. **Figure 12** provides a list of the prevalent pedestrian crash types, while **Figure 13** shows the distribution of five of the most common crash types by age group. This distribution by age group highlights the increased prominence of non-crossing roadway crashes among vulnerable users, as compared to other age groups, notably Dash/Dart-Out and Off-Roadway crashes for younger users (28% of crashes for pedestrians under 12 years old and 21 percent of crashes for pedestrians between 12 and 18 years old, while only accounting for 9 to 14 percent of crashes in other age groups), and Backing Vehicle crashes for users older than 65 years old (22 percent of crashes for pedestrians over 65 years old, while only accounting for 6 to 14 percent of crashes in other age groups).

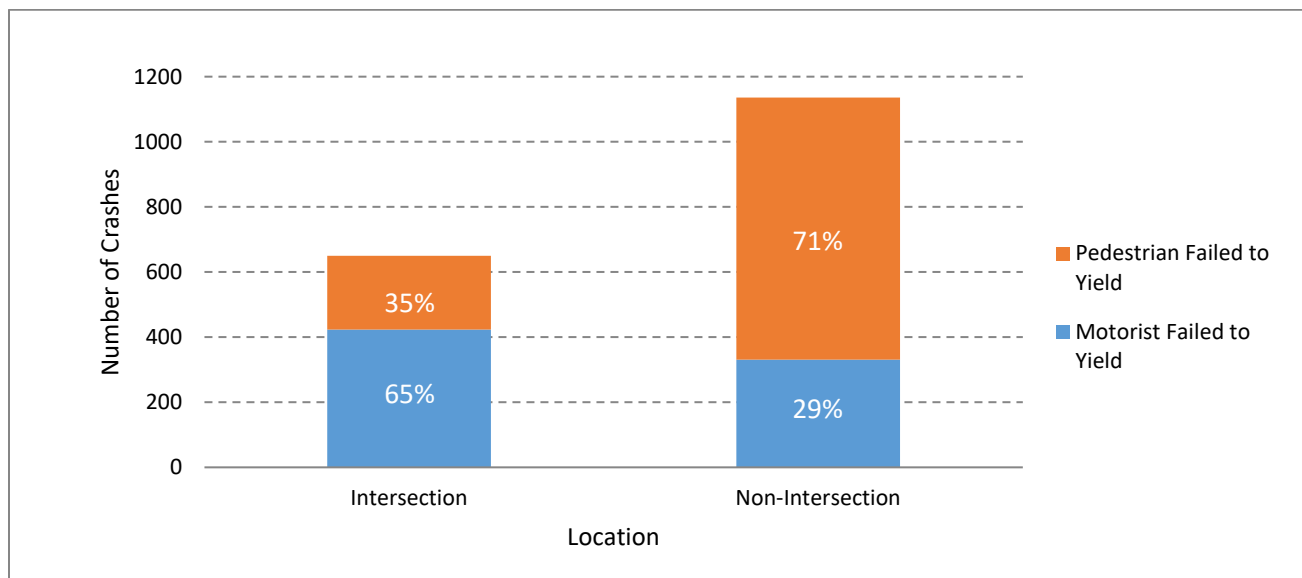
Figure 14. Non-Turning Roadway Crossing Crashes by Fault

Among the Crossing-Roadway Non-Turning crashes, the crash is further identified as either motorist or pedestrian failed to yield. These crashes can occur at either intersection (36 percent) or non-intersection (64 percent) locations, and the distribution by fault and location is provided in **Figure 14**. The party identified as failing to yield varies depending on the location. At intersections, where marked or unmarked crosswalks are more prevalent, the motorist is noted as failing to yield in 65 percent of the crashes (35 percent pedestrian failed to yield). However, at non-intersection locations the motorist is noted as failing to yield in 29 percent of the crashes (71 percent pedestrian failed to yield).

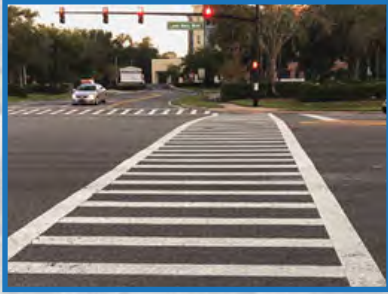
Issue #18:
Crosswalk markings should be upgraded to special emphasis markings.

Recommendation #18:
Restripe with special emphasis markings for all crosswalks.

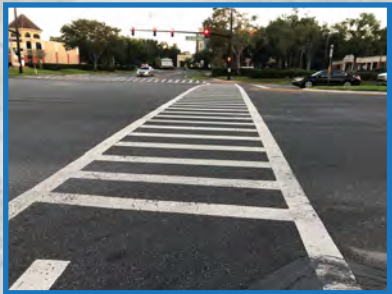
**4 Winds Boulevard
Issue #9:**
No marked crosswalk
on the west leg of the
intersection.

**4 Winds Boulevard
Recommendation #9:**
Add special emphasis
crosswalk on the west leg of
the intersection.

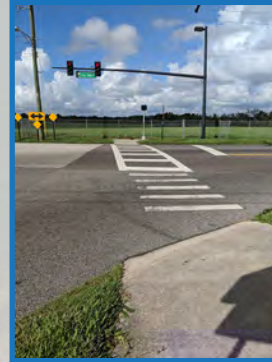
Dixie Belle Drive Issue #2:
Pedestrian crosswalk markings faded on north and south leg.

Dixie Belle Drive Recommendation #2:
Restripe the crosswalks on the north and south legs of the intersection with special emphasis markings.

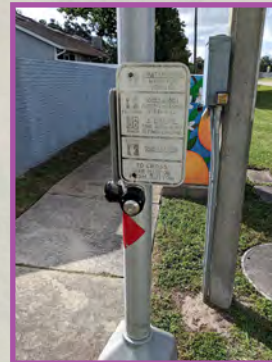
Dixie Belle Drive Issue #1:
Pedestrian push signage at the intersection is worn.

Dixie Belle Drive Recommendation #1:
Replace all pedestrian push button signage.

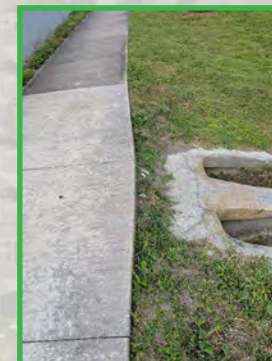
Thornbriar Lane Issue #3:
The sidewalk on the southwest corner of the intersection is elevated above drainage ditch.

Thornbriar Lane Recommendation #3:
Add a pedestrian railing at this location.

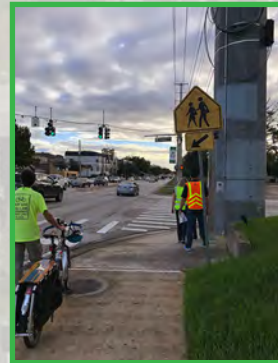
Osceola Avenue Issue #15:
School crossing signage facing eastbound traffic is worn and faded.

Osceola Avenue Recommendation #15:
Replace the school crossing signage with a fluorescent school crossing sign (MUTCD S1-1).

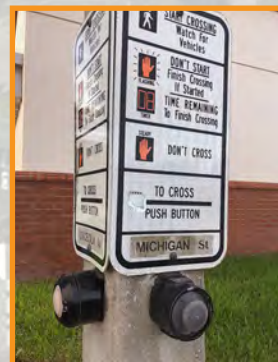
Osceola Avenue Issue #16:
Push button is missing for the west leg crosswalk in the southwest corner.

Osceola Avenue Recommendation #16:
Replace the pedestrian push button.

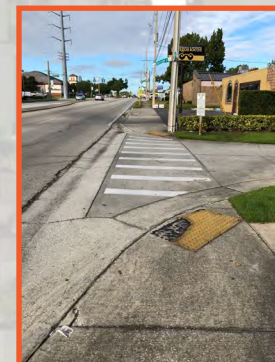
Storrow Drive Issue #21:
Truncated domes in the northeast corner are damaged.

Storrow Drive Recommendation #21:
Replace the truncated domes.

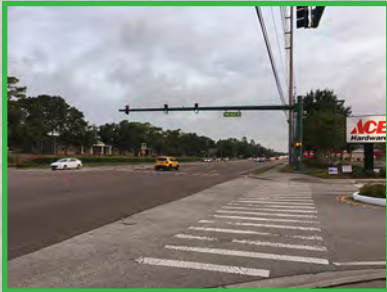
**Palm Valley Drive
Issue #11:**
The curb ramps at the
intersection are worn and
damaged.

**Palm Valley Drive
Recommendation #11:**
Repair and improve the
curb ramps at the
intersection.

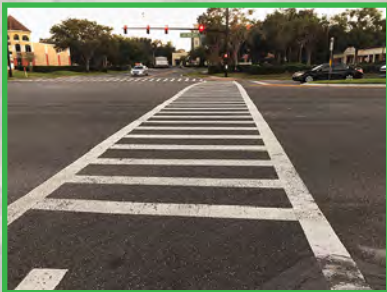
**Palm Valley Drive
Issue #10:**
Pedestrian crosswalk
markings faded.

**Palm Valley Drive
Recommendation #10:**
Restripe the crosswalks on
all legs of the intersection
with special emphasis
markings.

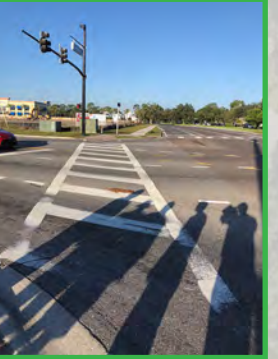
Longwood/Lake Mary Road Issue #13:
The south leg crosswalk is skewed, and northbound vehicles were observed stopping in the crosswalk due to the skew.

Longwood/Lake Mary Road Recommendation #13:
Make the crosswalk parallel to Lake Mary Boulevard by shifting the west side further to the north.

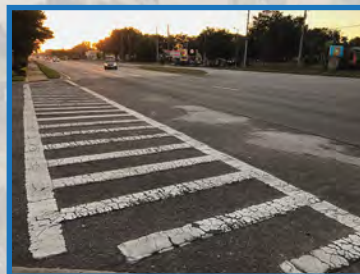
Willow Run Road Issue #8:
Pedestrian crosswalk markings faded on the north leg of the intersection.

Willow Run Road Recommendation #8:
Restripe and resurface the crosswalk on the north leg of the intersection with special emphasis markings.

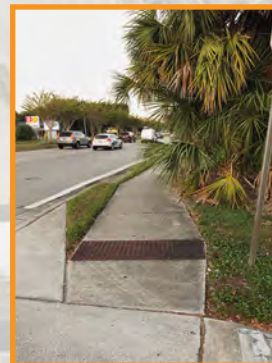
Wells Fargo Entrance Issue #9:
The bushes on the northwest corner of the intersection obstruct sight distance.

Wells Fargo Entrance Recommendation #9:
Cut the bushes to improve sight distance.

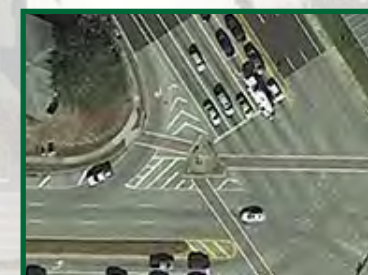
Tuskawilla Road Issue #12:
The raised pedestrian refuge on the northwest corner of the intersection is small and the southbound right turn lane is wide, which encourages high turning speeds.

Tuskawilla Road Recommendation #12:
Increase the size of the raised pedestrian refuge to increase pedestrian and bicyclist comfort and reduce driver turning speeds. Also consider a raised crosswalk within the channelized right turn lane.

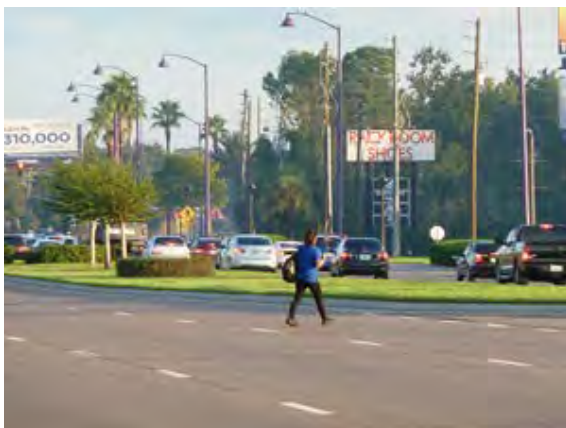
Figure 41. Mid-Block Crossing Issue

- Issue – Majority of fatal crashes along safety field review corridors occurred at mid-block locations with pedestrian/bicyclist crossing main roadway outside of a marked crosswalk (**Figure 41**).

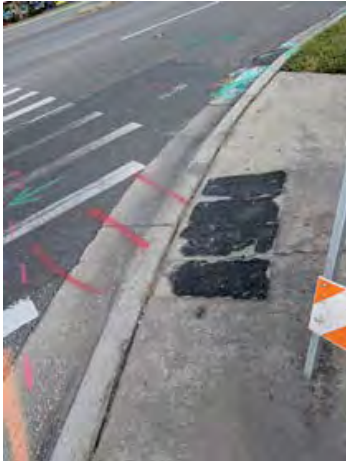
Figure 43. Curb Ramp Issue

- Note that in Orange County, Duke Energy will be performing the lighting assessments.
- Issue – Truncated domes worn down or missing at curb ramps for signalized intersections (**Figure 43**).

- Recommendation – Work with the roadway maintaining agency to replace or install new truncated domes.
- Issue – Pedestrian crosswalk markings were faded at signalized intersections (**Figure 44**).

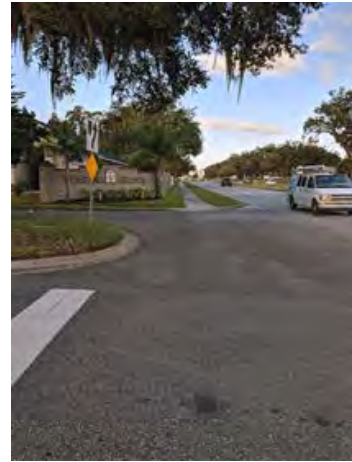
Figure 45. No Marked Crosswalks Issue

- Recommendation – Work with the roadway maintaining agency to restripe crosswalks at regular intervals.
- Issue – No marked crosswalks across public street approaches at unsignalized intersections (**Figure 45**).

- Recommendation – Install marked crosswalks across the public street approaches at unsignalized intersections.

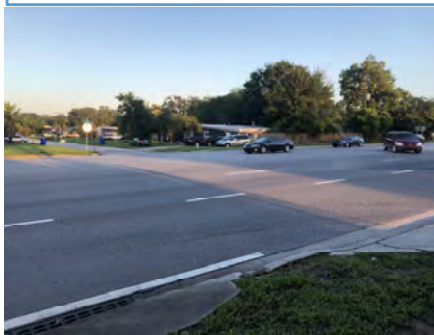
Full median opening at Lehigh Street with 1 pedestrian fatal crash (Issue #4)

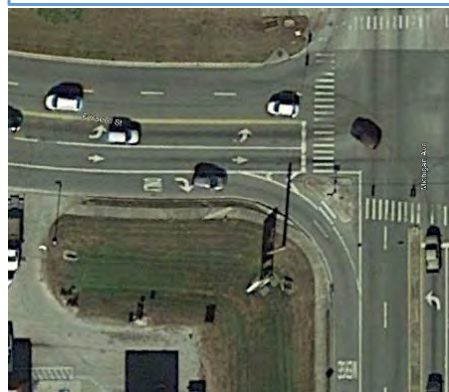
Free-flow eastbound right turn lane at Carroll Street (Issue #17)

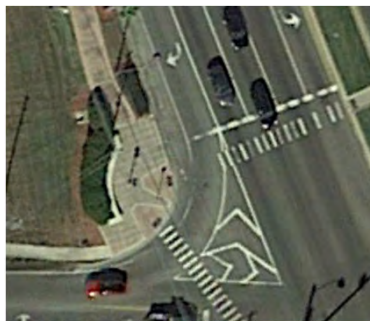
High speed southbound right turning movements at Siesta Lago Drive (Issue # 4)

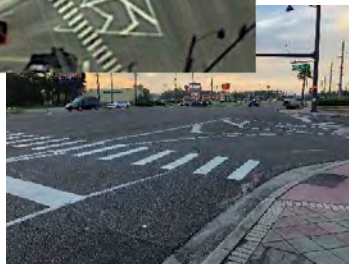
Bike lane is faded and conflicts with right turn vehicle movements at Old Vineland Road (Issue #15)

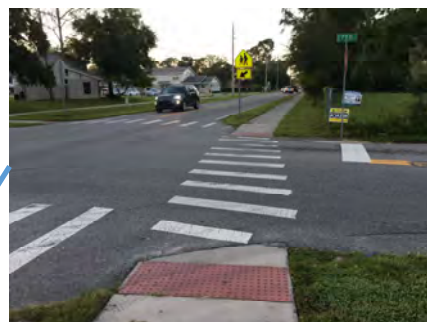
Enhance the uncontrolled east/west crossings at 17th Street (Issue #2)

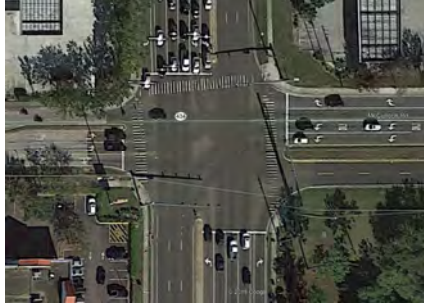
No marked crosswalk on the south leg of McCulloch Road (Issue #1)

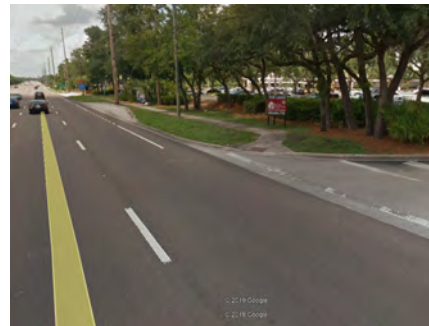
Curb ramps lead pedestrians into SR 434 at Publix Driveway (Issue #6)

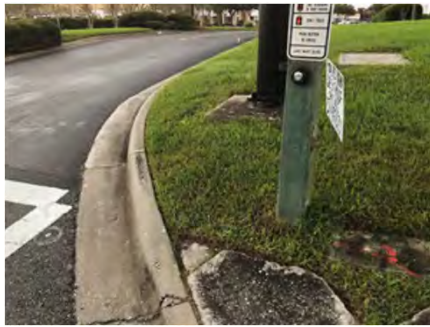
Inaccessible pedestrian push buttons at Lake Mary Center (Issue #1)

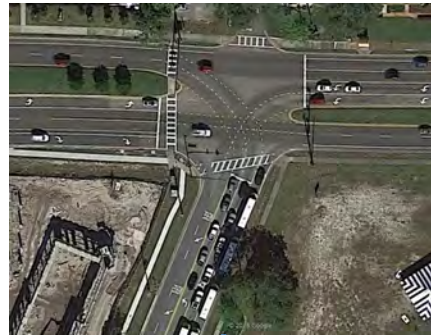
Second NB right turn lane is planned at Longwood Lake Mary Road (Issue #12)

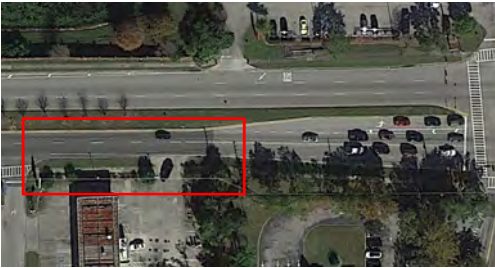
EB bike lane ends near Shell gas station driveway before reaching Plaza Entrance signal (Issue 10)

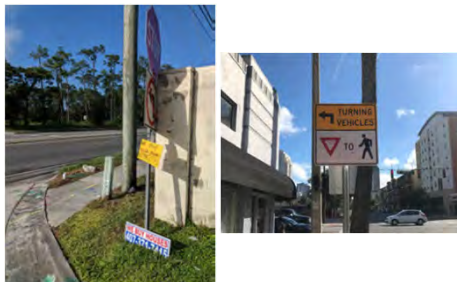
Sight distance restrictions at 7/11 driveway (Issue #18)

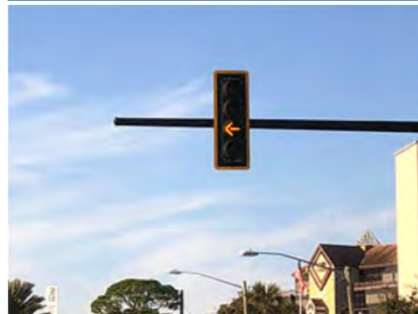
Permissive EB/WB left turn vehicles conflict with school children at Mills Avenue (Issue #22)

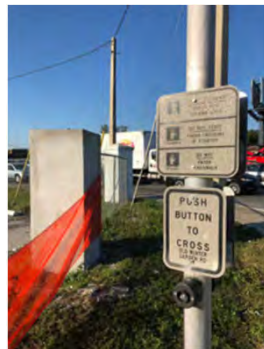
Pedestrian push button signage is worn/damaged at John Young Parkway (Issue #2)

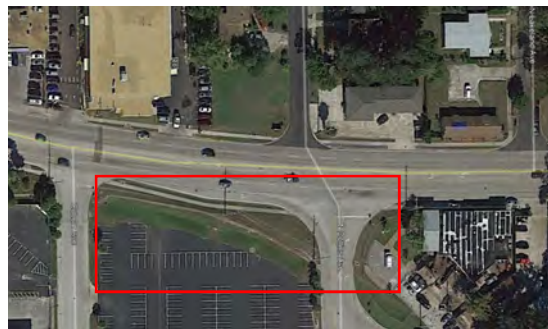
EB right turn lane and large curb return radii encourage higher turning speeds. The 2 NB lanes increase pedestrian crossing distance at Dollins Avenue (Issue #7)

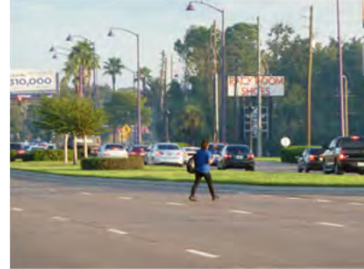
Multiple fatal crashes occurred with
peds/bikes crossing mid-block

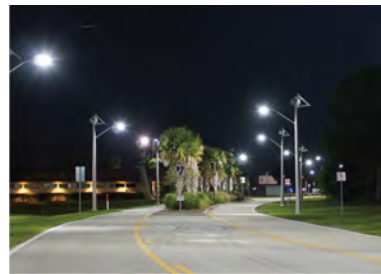
Very few corridors with street lighting;
nighttime ped/bike crashes between 25 and 45
percent

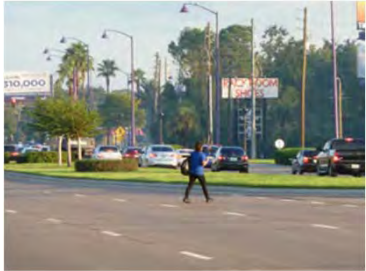
Multiple fatal crashes occurred with peds/bikes crossing mid-block

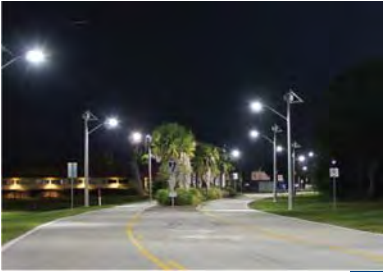
Very few corridors with street lighting; nighttime ped/bike crashes between 25 and 45 percent

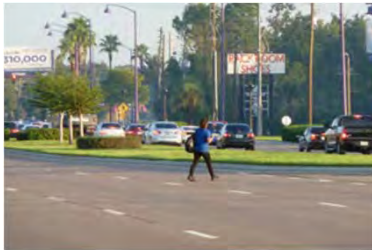
Multiple fatal crashes occurred with peds/bikes crossing mid-block

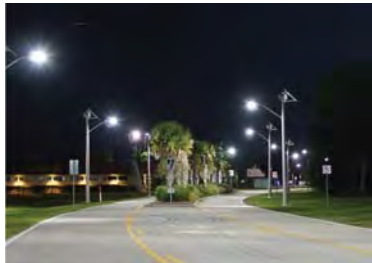
Few of these corridors have street lighting; night-time ped/bike crashes between 25 and 45 percent

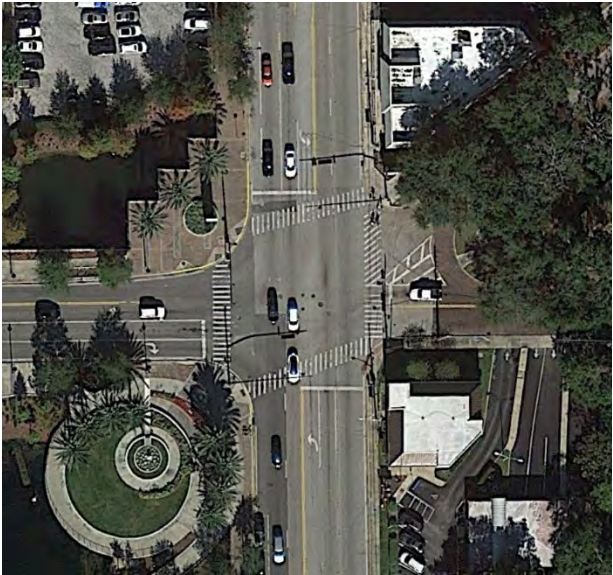
Skewed Crosswalk

Issue: Crosswalk is not perpendicular to the roadway, creating a longer crossing distance, and potentially distancing crossing pedestrians from their expected crossing position at the intersection.

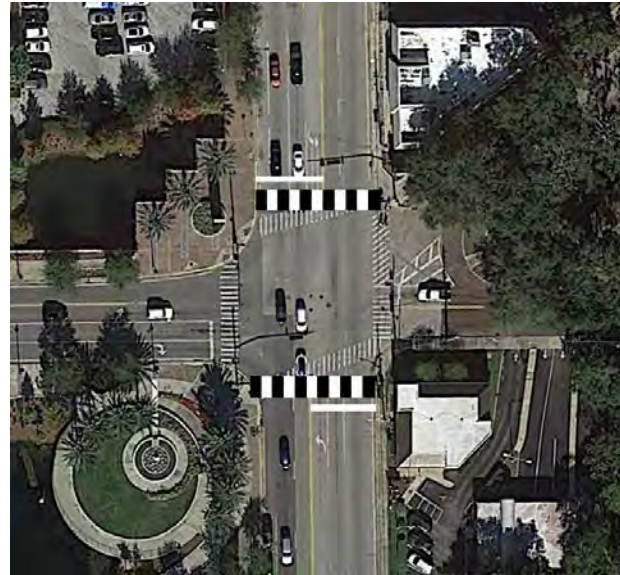
Perpendicular Crosswalk

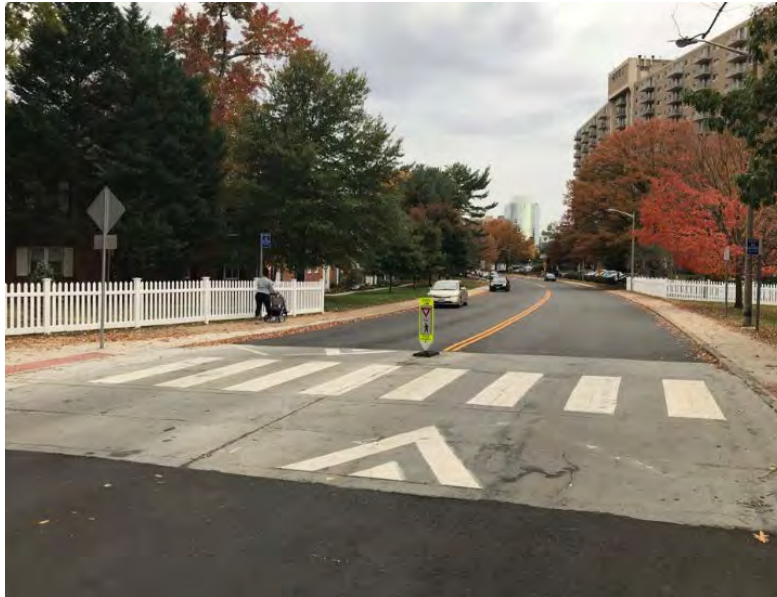
Raised Crosswalk

Issue: High speeds or poor vehicle yielding/stopping at marked crosswalks.

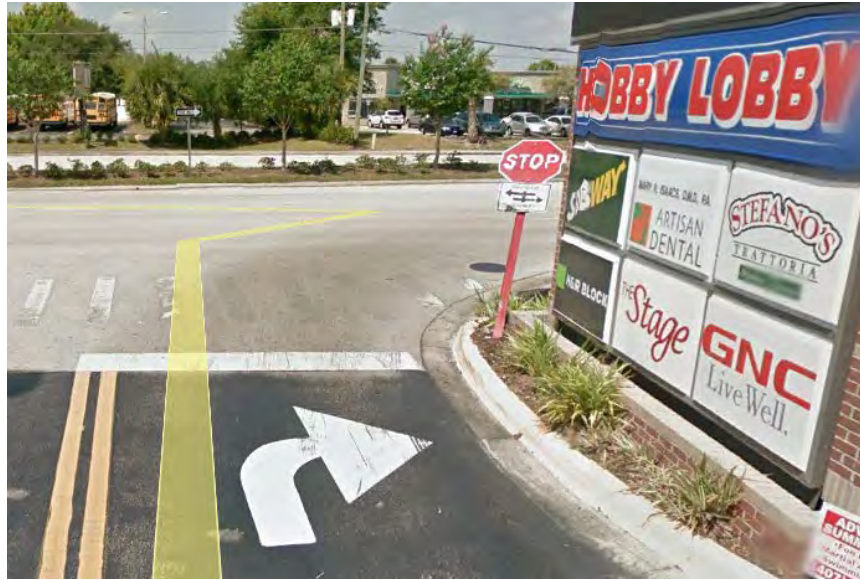
Sign Sight Obstruction

Issue: Obstructed visibility of pedestrians in advance of crossing an intersection or driveway.

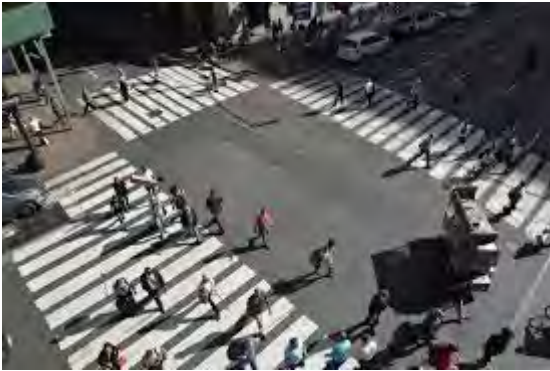
Exclusive Pedestrian Phase

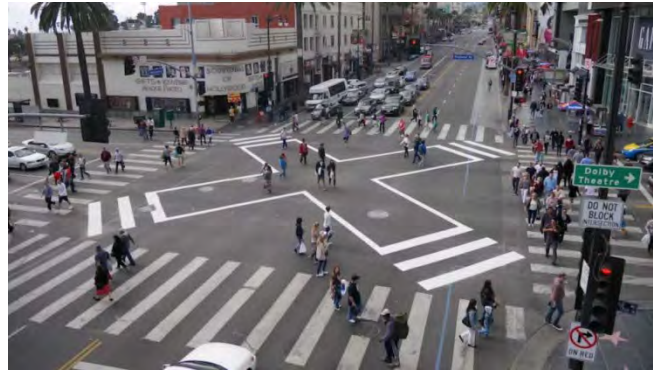
Exclusive Pedestrian Phase with Diagonal Crossing

Issue: High number of pedestrian conflicts with turning vehicles at a signalized intersection or poor motorist yielding rates involving turning movements during concurrent walk phases at signalized intersections.

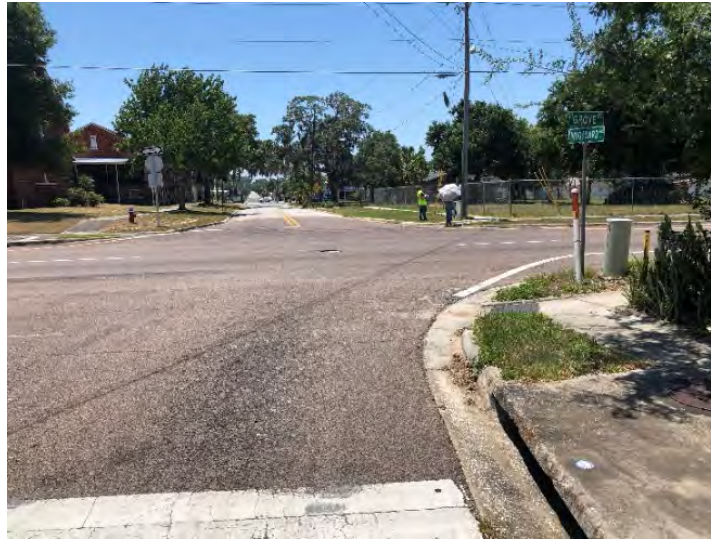
Stop Bar Set Back too Far

Stop Bar Relocation

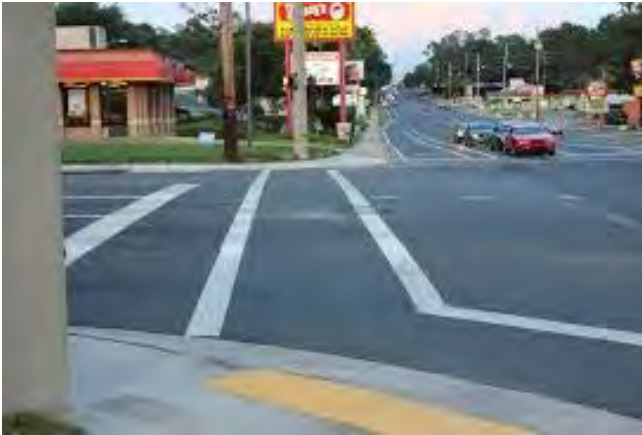
Standard Crosswalk Marking

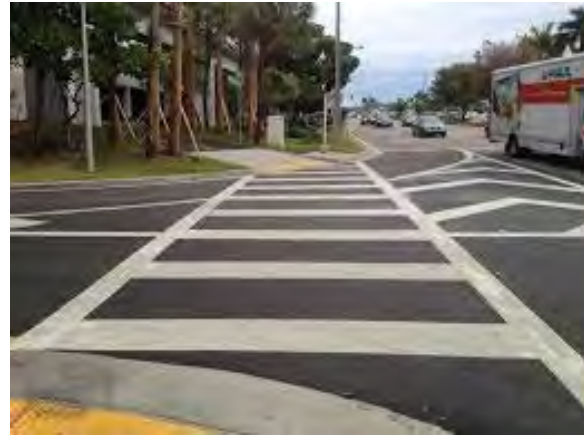
Special Emphasis Crosswalk Marking

Issue: Existing crosswalk at a stop-controlled or signal-controlled approach is not marked or does not have conspicuous existing markings.

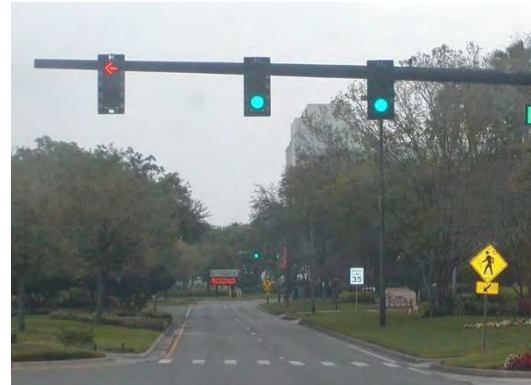
Protected Only Signal Phasing

Issue: At a signalized intersection, left-turning vehicles are not properly yielding to pedestrians who cross during the concurrent walk phase.

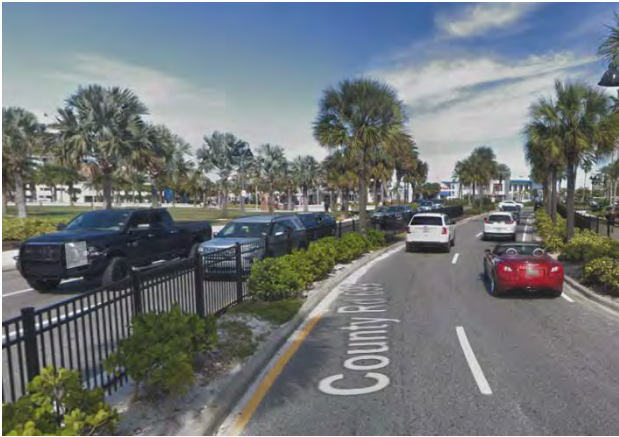
Median Pedestrian Barrier

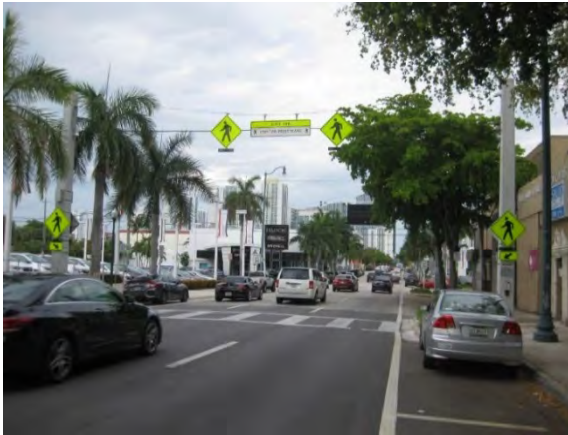
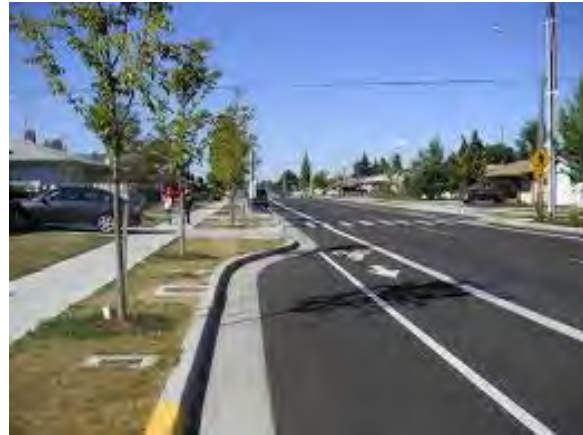
Marked Mid-Block Crosswalk

Issue: Insufficient safe roadway crossing opportunities due to intersection spacing or specific pedestrian demand.

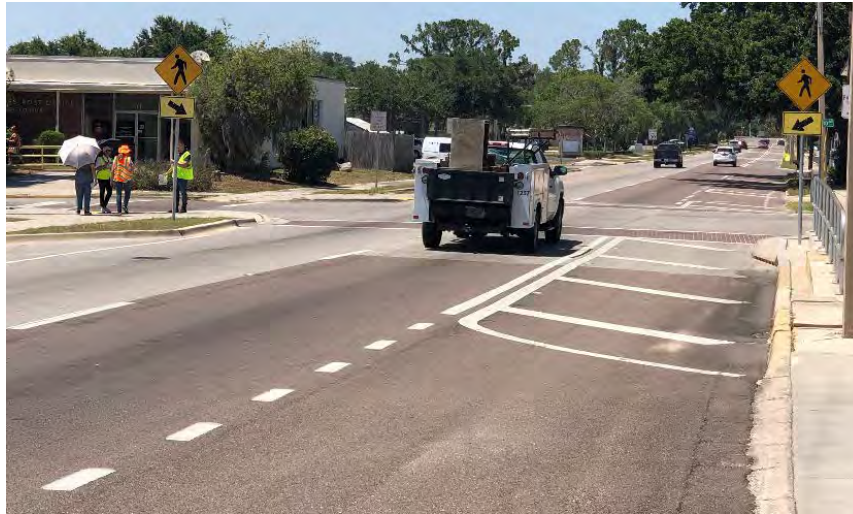
Restricted On-Street Parking Near Driveways and Intersections

Issue: Limited visibility at intersections, driveways, or mid-block crossings due to on-street parking adjacent to the location.

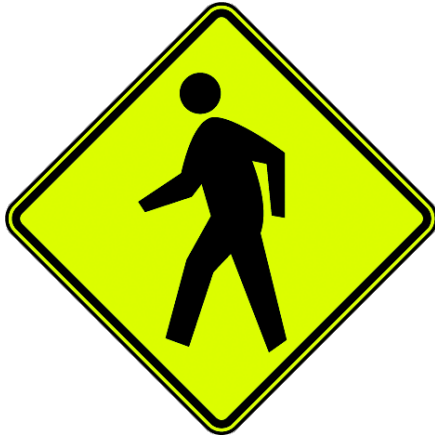
Pedestrian Warning Sign (MUTCD W11-2)

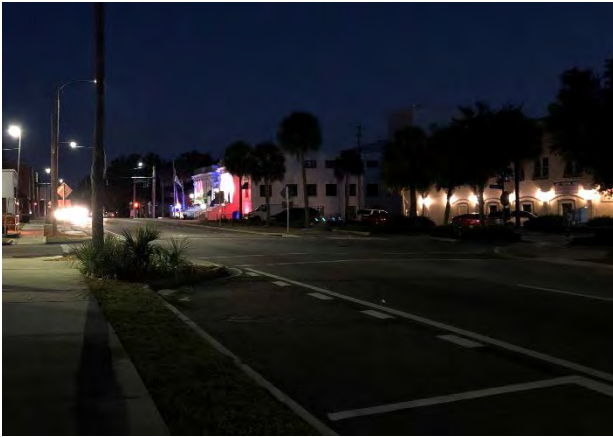
Unlit Crosswalk

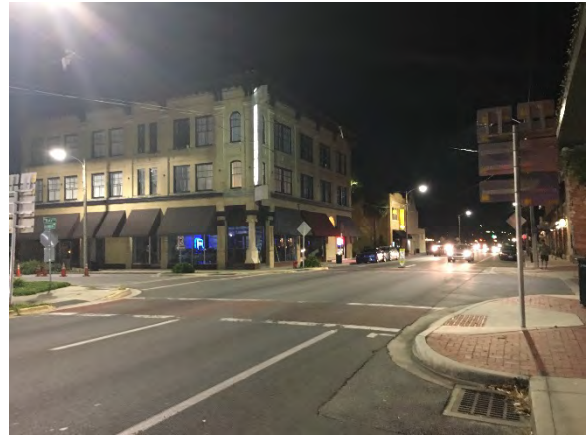
Crosswalk with LED Lighting

Issue: Dark spots along a corridor at driveway crossings, at stop-controlled intersections, or at signalized intersections. Potential dark spots may exist either on the sidewalk at the approach of a crossing location or mid-crossing.

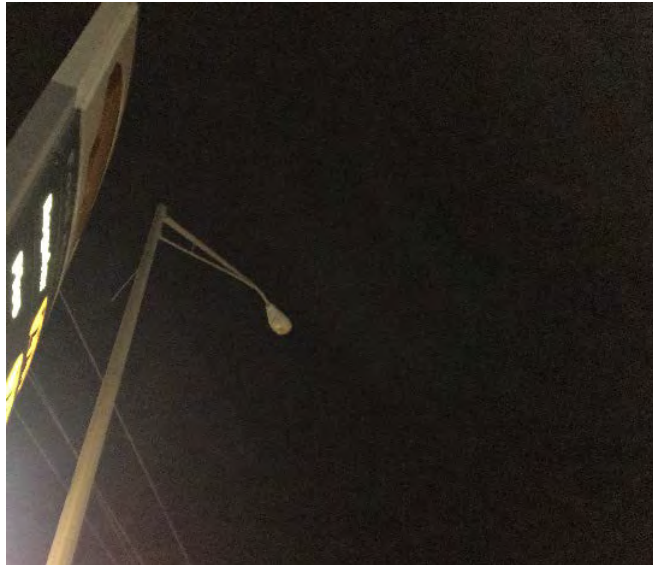
Inoperable Luminary

Lighting Maintenance

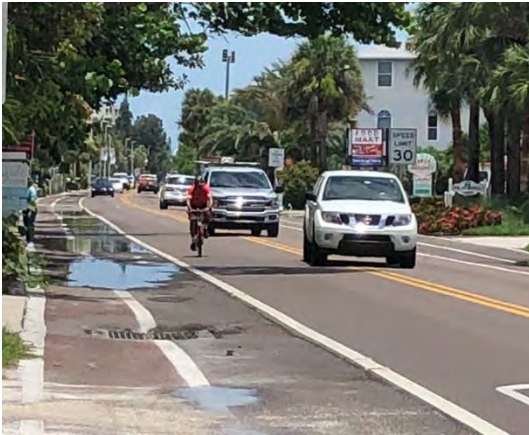
Pedestrian/Bicyclist Water Hazard

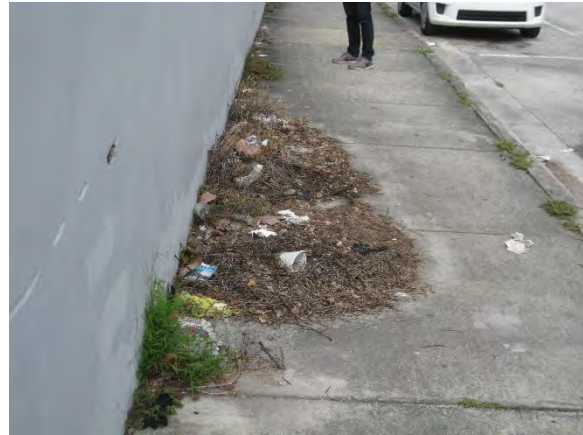
Debris Leftover from Pooled Water

Issue: Pooled water forming on the sidewalk or at curb ramps that both renders the sidewalk temporarily impassible and leaves behind debris that can cause a slipping hazard on the sidewalk.

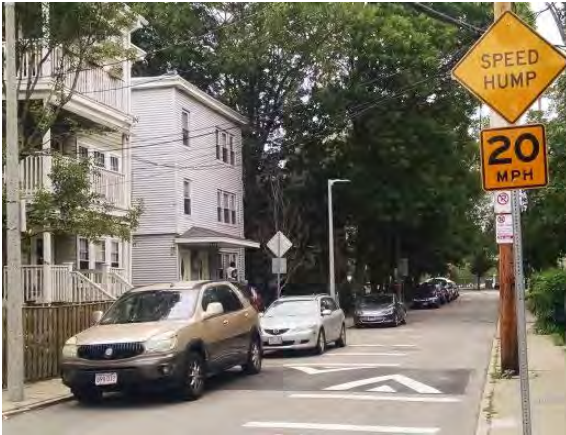
Speed Hump

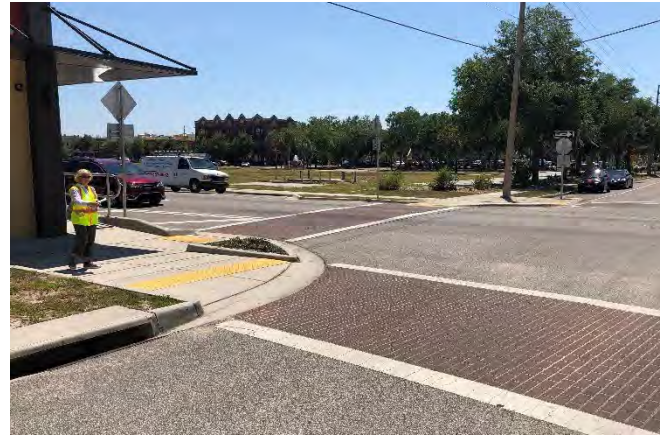
Intersection Bulb-Outs Combined with On-Street Parking and Stamped Asphalt Crosswalk Markings

Issue: High vehicle speeds and/or poor motorist yielding.

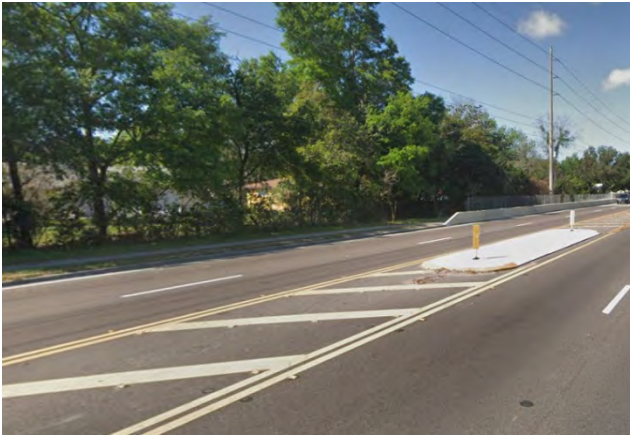
Spot Median

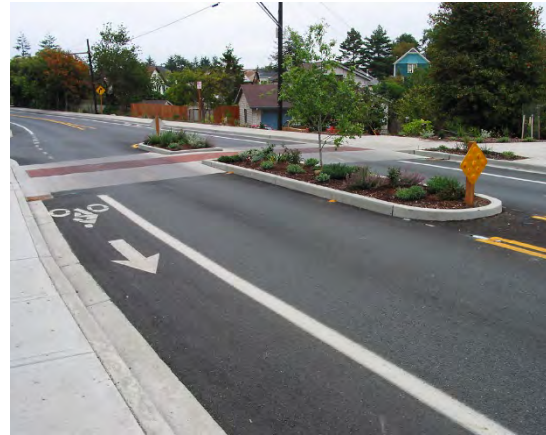
Spot Median with Pedestrian Crossing

Issue: Limited pedestrian crossing opportunities on undivided roadways or roadways with center two-way left-turn lanes.

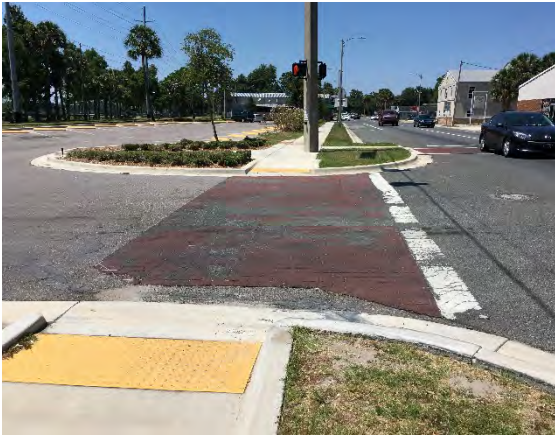
Curb Extension at Intersection

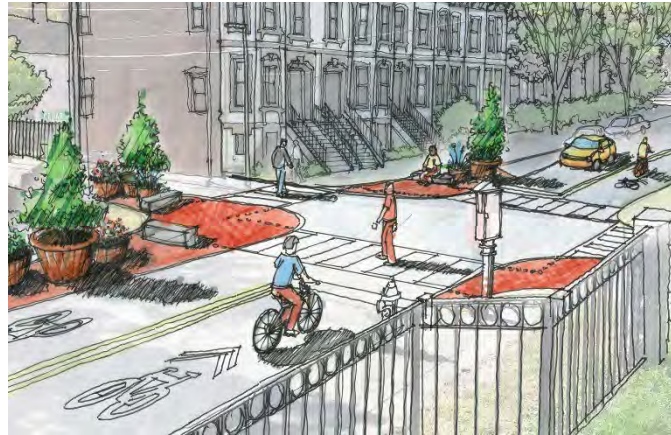
Conceptual Intersection Curb Extensions

Issue: Large crossing distances or wide roadway cross-section that encourage high speeds.

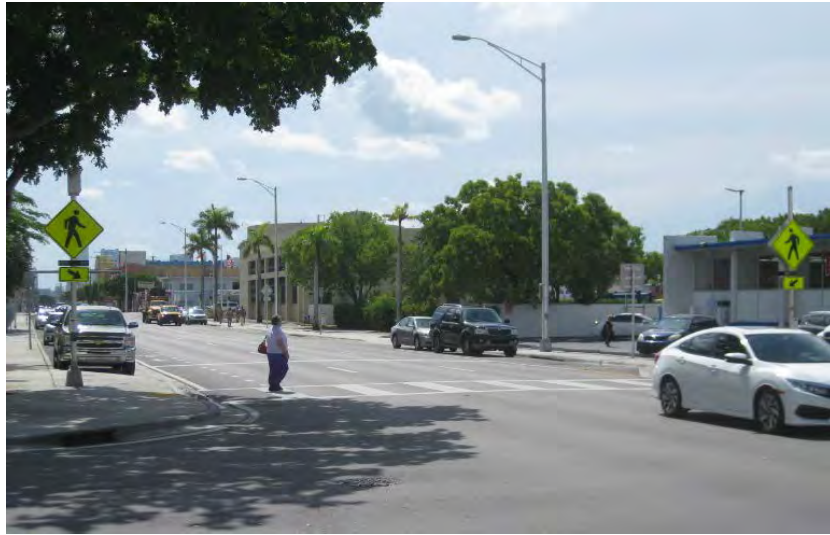
Crosswalk with Rectangular Rapid Flashing Beacon

Issue: Mid-block or uncontrolled intersection crossing location.

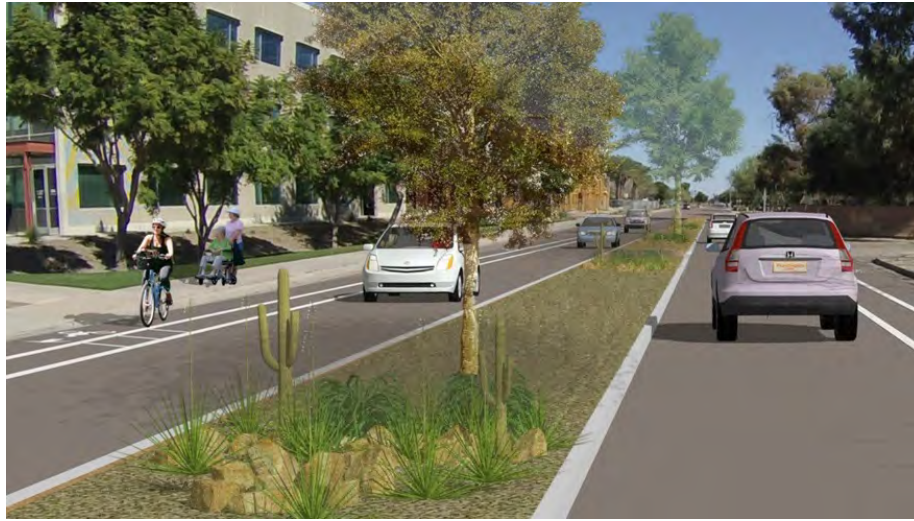
Conceptual Median and Bicycle Lane with Lane Elimination

Issue: Excessive vehicle speeds, insufficient bicycle or pedestrian facilities, or insufficient pedestrian separation from vehicle traffic.

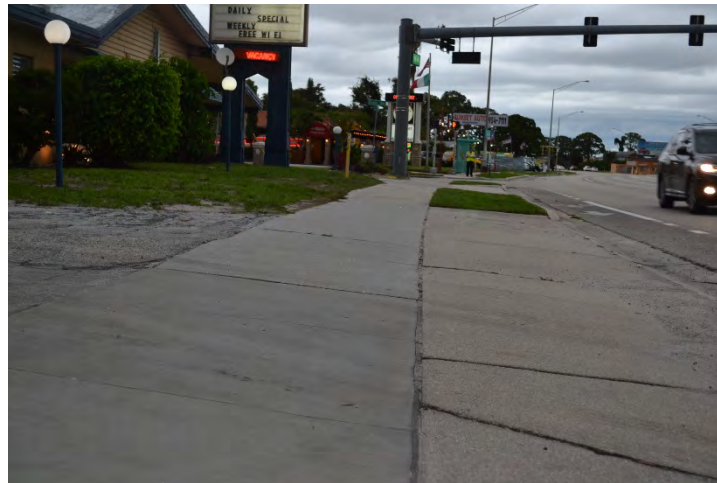
Wide Driveway Entrance with Steep Cross-Slope and Large Turning Radius

Issue: Steep cross-slopes across driveways, wide driveway entrances, large turning radius at driveways encouraging high speed turning movements.

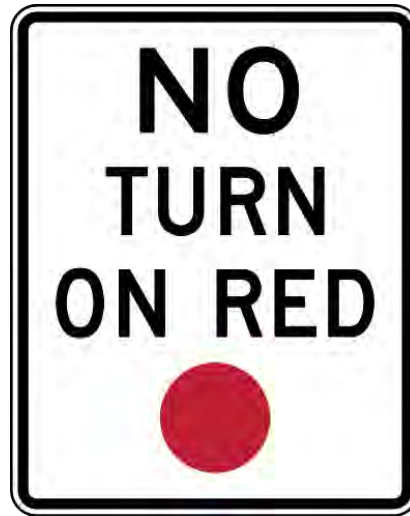
MUTCD R10-11

Issue: Pedestrian-vehicle conflicts with vehicles attempting to complete a right-turn on red movement. When attempting this turning movement, drivers are frequently looking towards oncoming traffic and do not notice pedestrians who may be using the crosswalk.

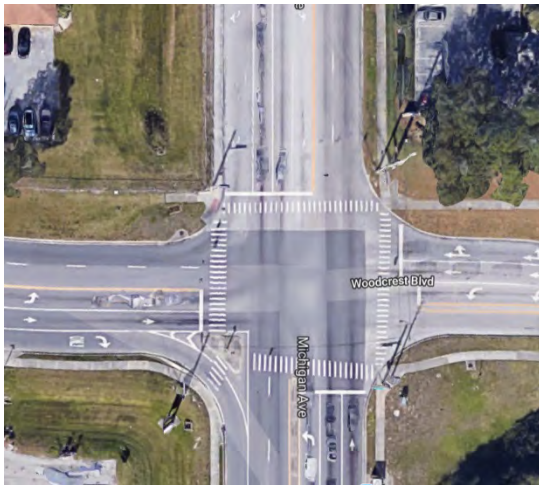
Channelized Right-Turn Lane without Improved Pedestrian Accommodations (not enhanced crosswalk, vehicle acceleration lane present)

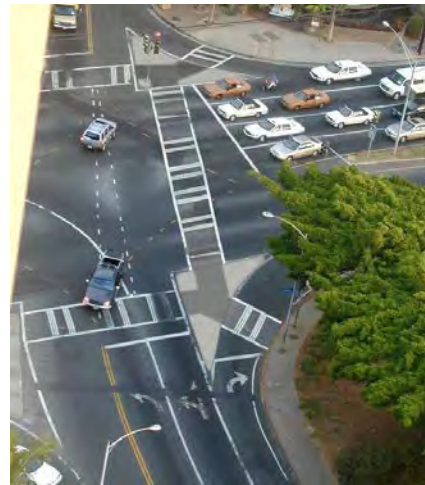
Channelized Right-Turn Lane with Enhanced Pedestrian Crossing

Issue: Pedestrian-vehicle conflicts due to channelized or free-flow high speed right-turn movements.

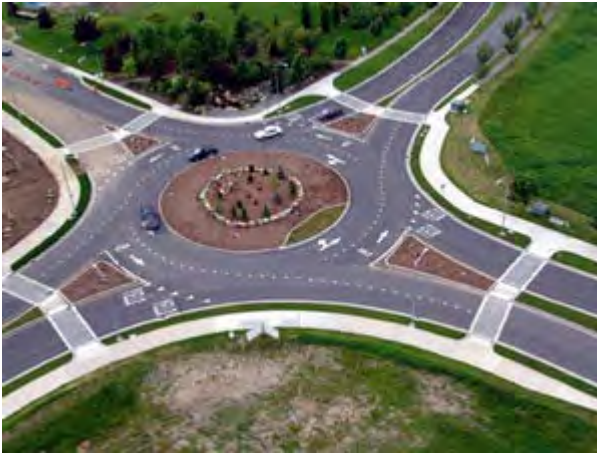
Roundabout with Pedestrian Accommodations

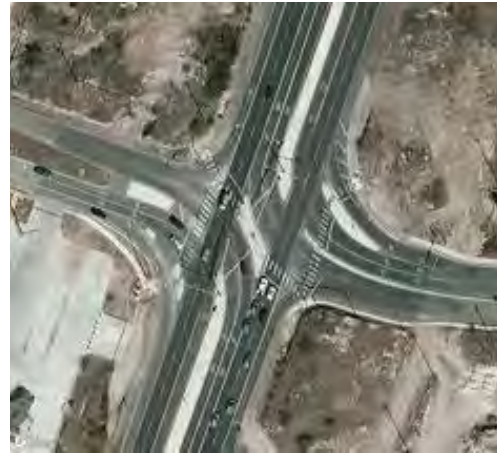
Restricted Crossing U-Turn Intersection with Crosswalks

Issue: Pedestrian-vehicle conflicts at two-way stop control or signalized intersection.

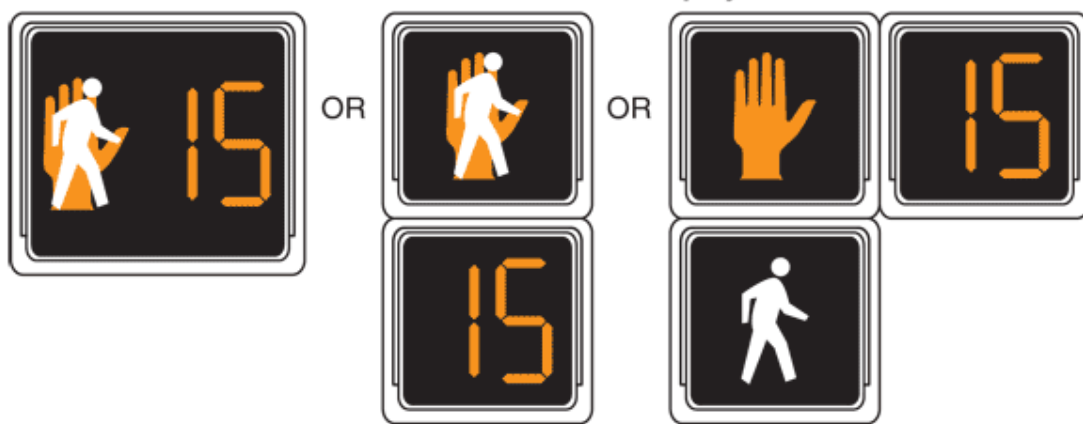
Pedestrian Countdown (MUTCD Figure 4E-1)

Issue: Pedestrians entering the crosswalk at a signalized intersection during the flashing don't walk phase without sufficient crossing time.

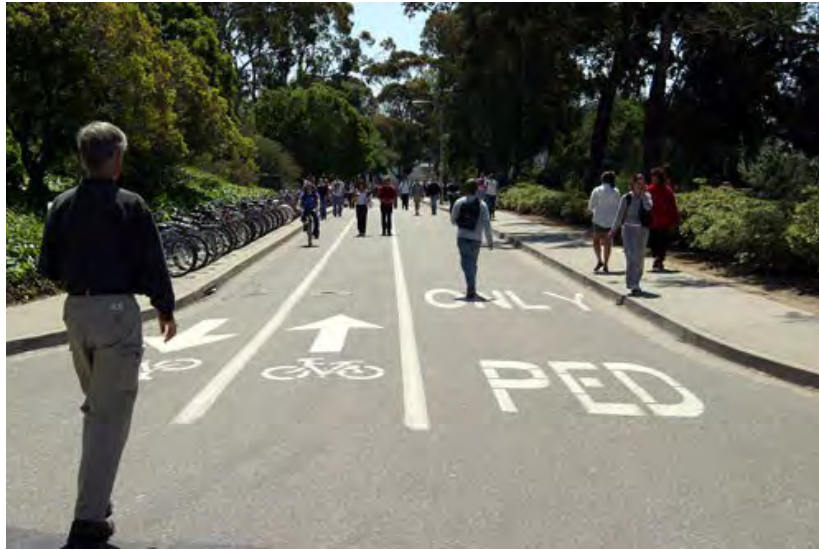
Pedestrian/Bicyclist Only Facility

Issue: Complex intersections or insufficient right-of-way availability leading to pedestrian-vehicle conflicts that cannot be addressed through other countermeasures.

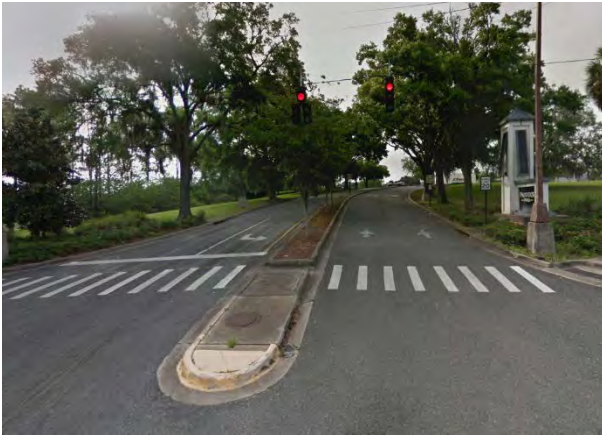
No Sidewalks Provided for Mall Access
(pedestrians must walk in road)

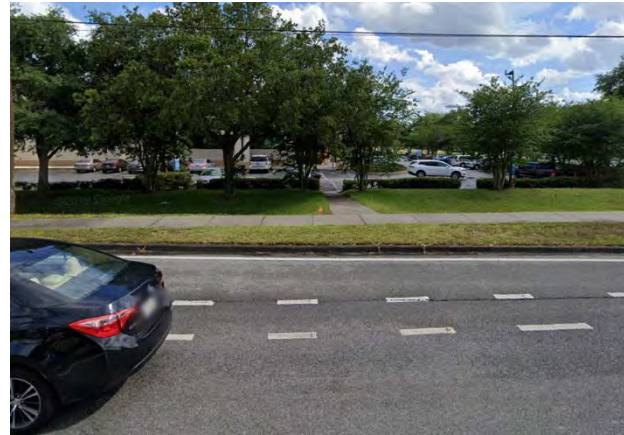
Sidewalk Connectivity Provided for Retail
Access

Issue: Pedestrians traveling along a corridor are not provided with a sidewalk connection to access a shopping center or business, forcing pedestrians to walk in the driveway or access road.

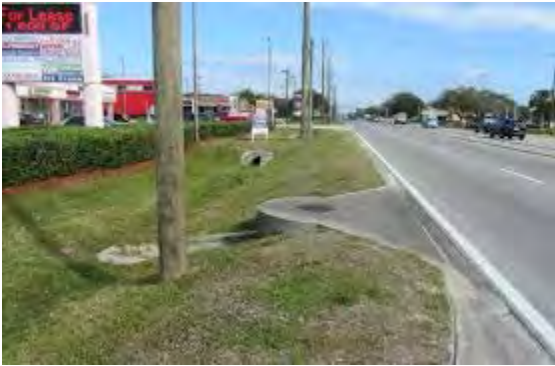
Sidewalk Gap

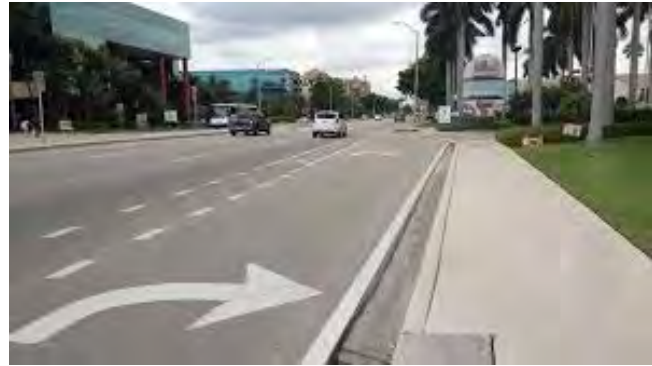
Continuous Sidewalk

Issue: Lack of sidewalk or other pedestrian facility resulting in pedestrians walking in potentially hazardous conditions.

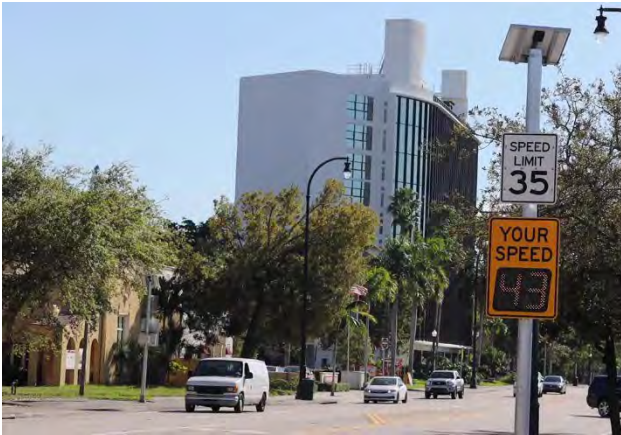
Speed Limit Sign with Driver Feedback Sign
